Annele Matintupa, Seppo Tuisku

SUMMARY OF DRAINAGE ANALYSIS IN ICELAND

Demonstration Project Report

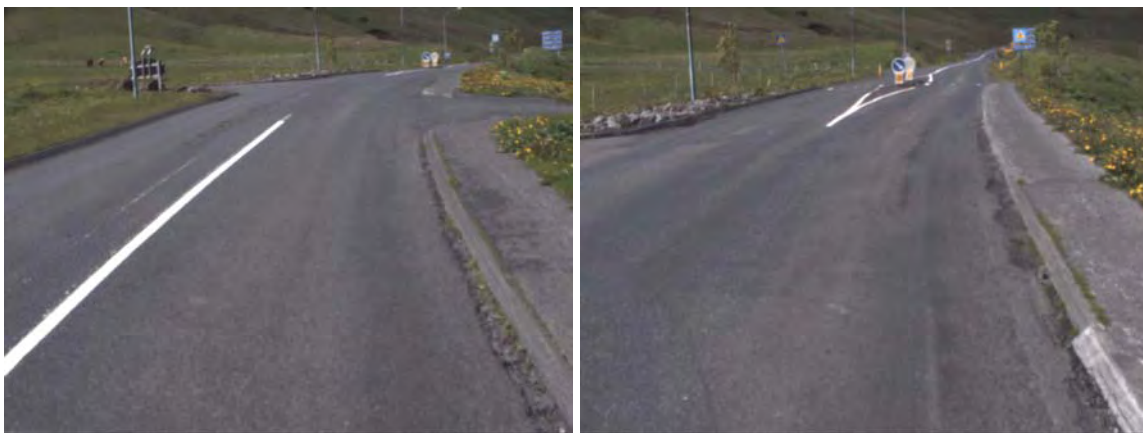
Figures 13: Footway kerb blocking water flow causing minor washout damages. Chainage on the left figure is from 10m, and on the right 30m.

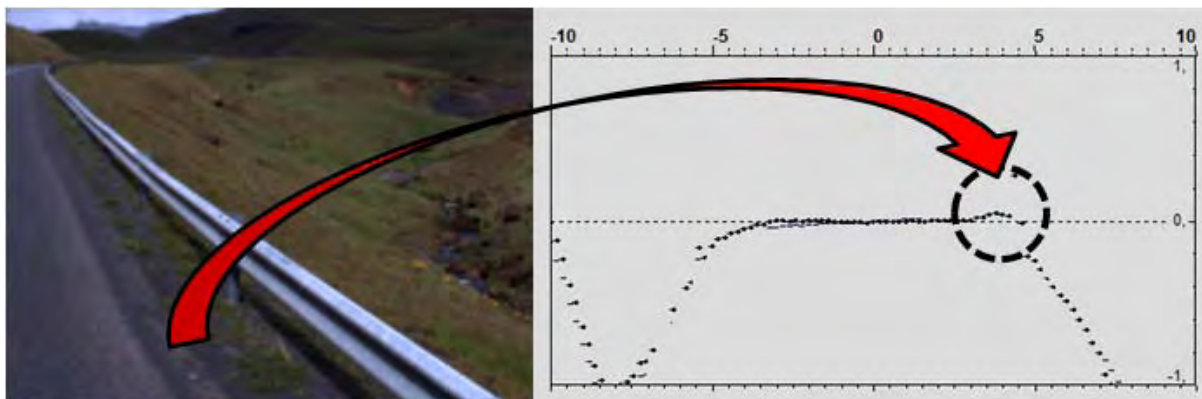
Figure 14: Verge under the guardrail, chainage 720m

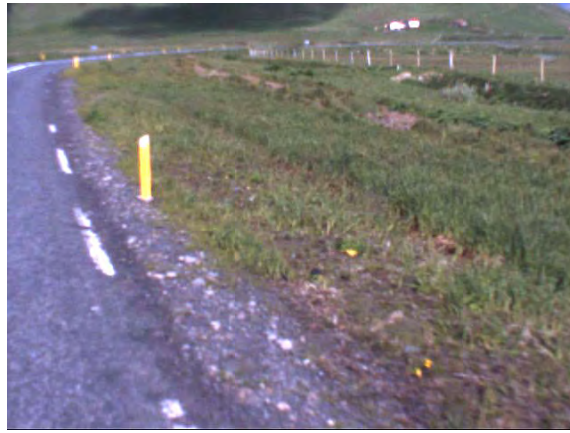
Figure 15: Minor drainage deficiencies on a curve. The ditch was placed far from the road behind the horse track (9480m).

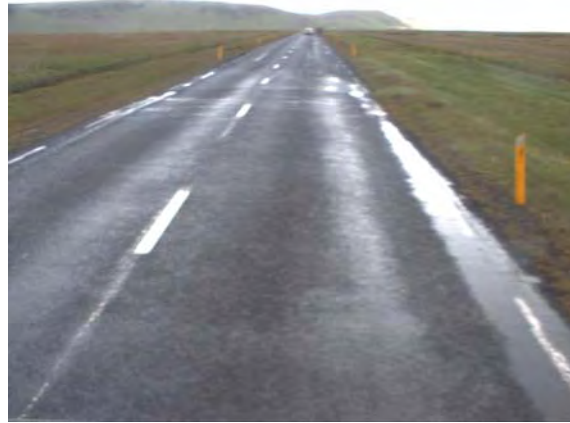
Section B5 of road 1 continued from the junction of road 218 to the junction of road 219, a length of 5760m. The drainage was in good condition, the few existing deficiencies noted were typical for the Icelandic drainage conditions and were related to the ditches which at times were located too far from the road to take care of the drainage in an efficient way. In some sections the verge was hindering the water flow from the pavement surface and causing ponding (Figure 17).

Figure 17: Verge is stopping the water on the edge of the pavement, chainage 3830m.

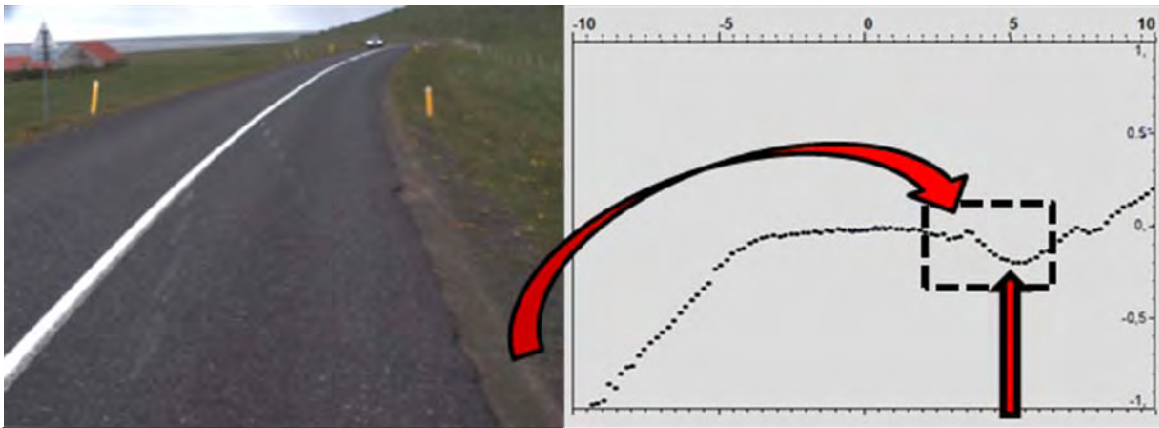
Within section B7 there were several lengths where verges were slowing the water flow from the pavement surface to the ditches. At times the ditches were shallow, and the vegetation growing on the road shoulder was hindering the water flow (Figures 19-20).

Figure 19: Shallow ditch and verge on the upper side of the side sloping road profile (3520m).

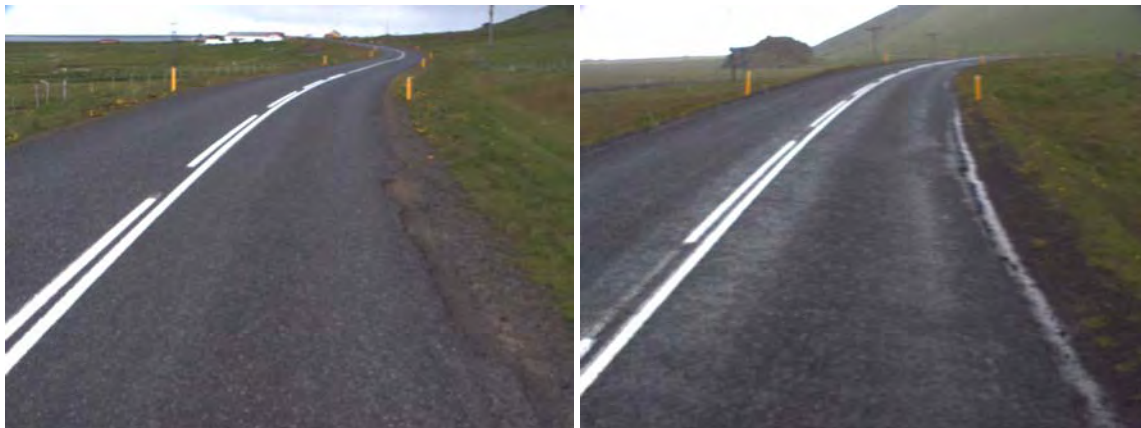
Figure 20: Shallow ditches and verge causing the water to infiltrate into the edge of the pavement (Chainage 2620m and 5700m).

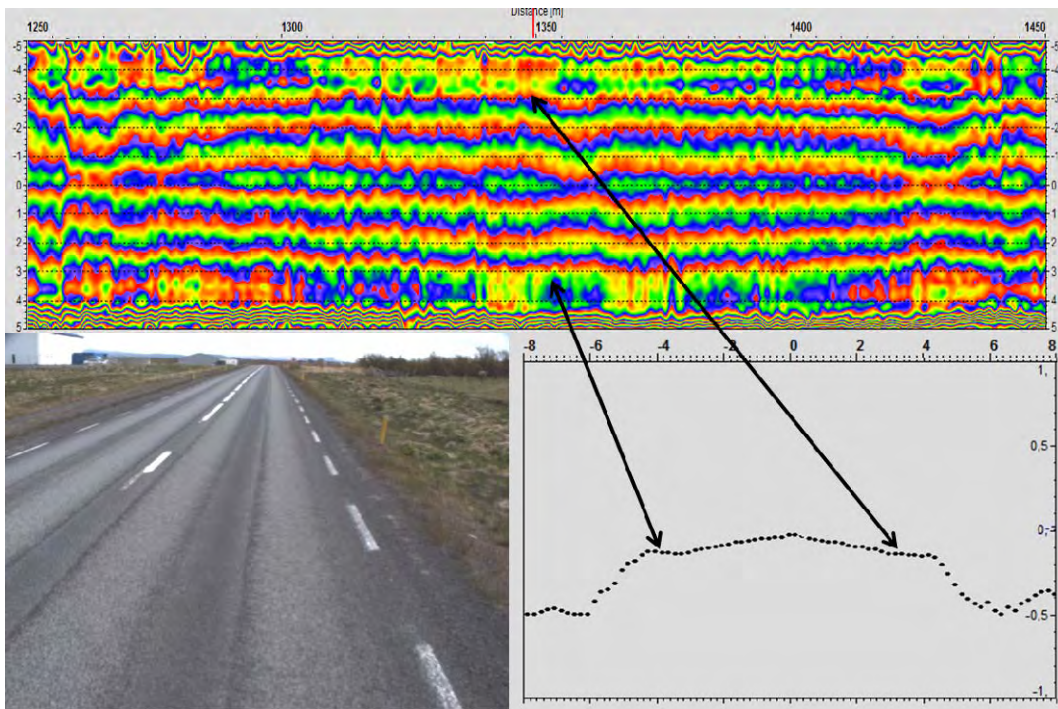
The rainbow map and the cross section data in Figure 21 show that the crown section was in generally good shape but that the road shoulders were somewhat elevated (possibly because of road widening). The ditches were located far from the road and the drainage was not working perfectly, but the IRI data did not show higher values compared to the later part of the section which was on embankment for the most part.

Figure 21: Strong elevated road shoulders at chainage 1350m.

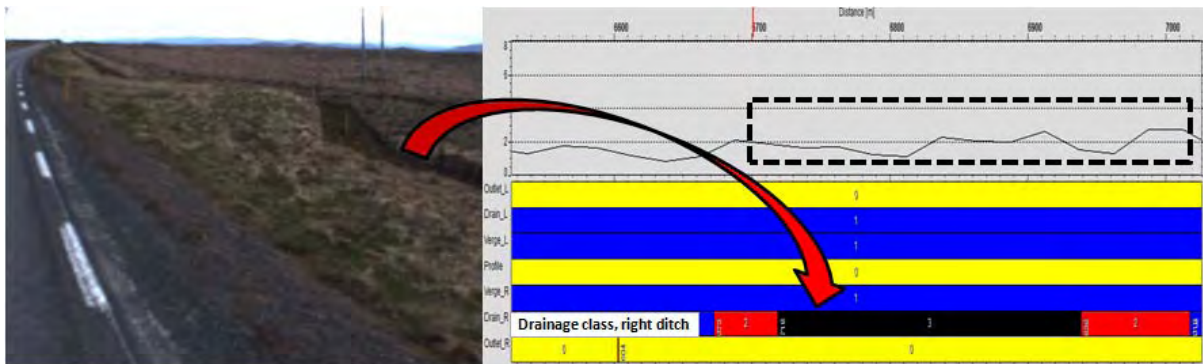
From chainage 6700m to 7000m the ditch on the right was full of water and vegetation but this did not seem to have any impact on the road. The IRI values in this particular section were not higher than the rest of the section (Figure 22).

Figure 22: Drainage is Class 3 but no change in IRI values, chainage 6700m.

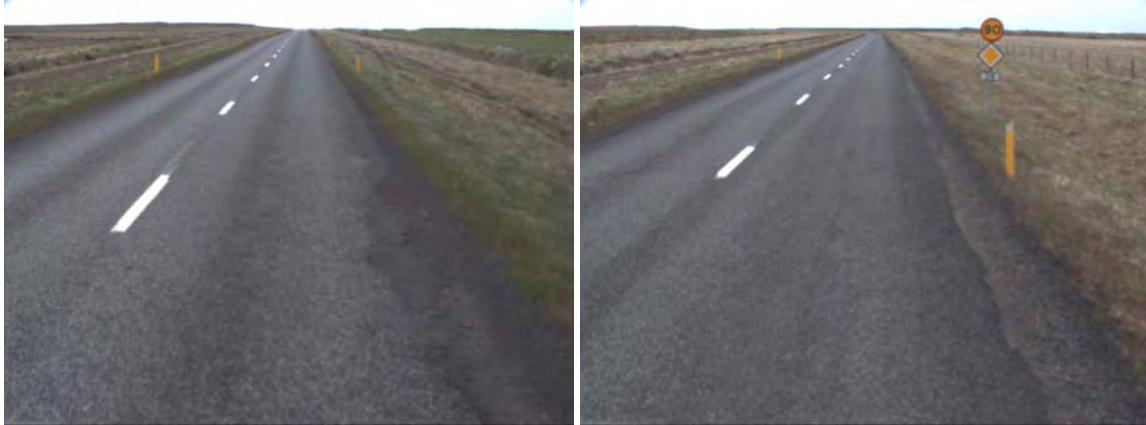
Figure 23: Verge hindering the water flow from the pavement surface (chainage 2850m, 3920m).

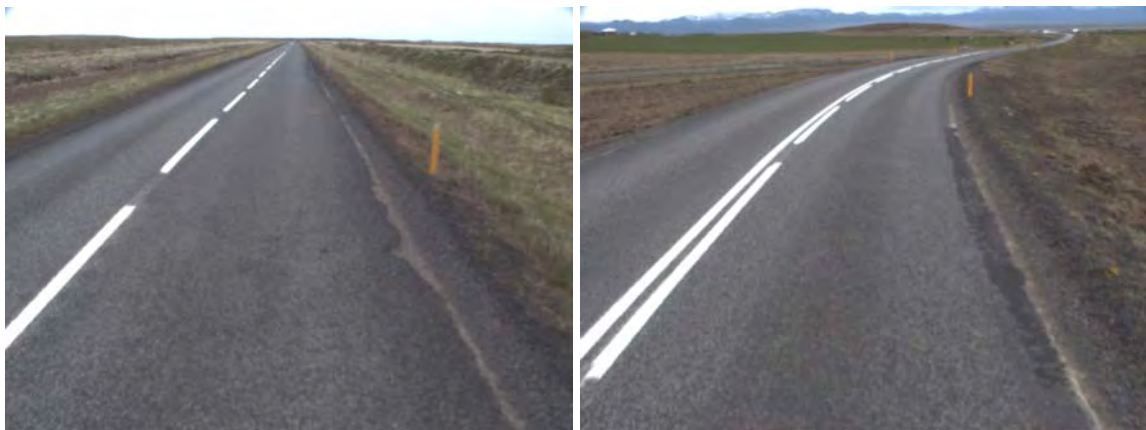
Figure 24: Problematic verge at chainage 4270m and 8830m.

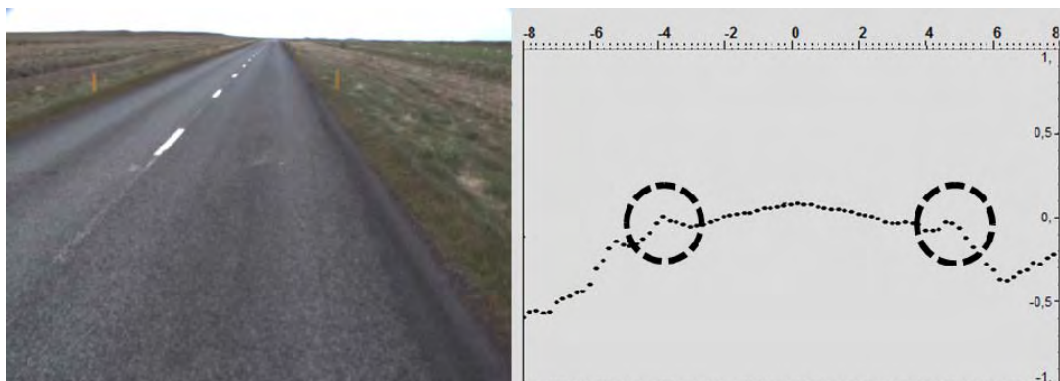
Figure 25: Verges on cross section view, chainage is 2650m.

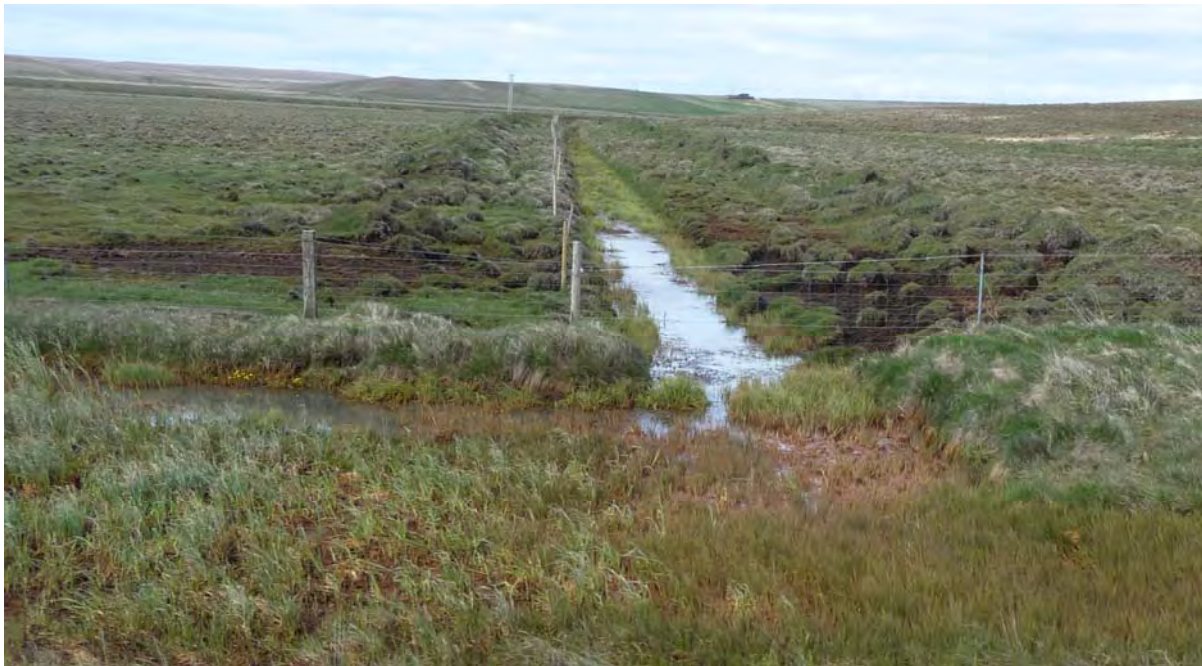
Figure 26: Outlet ditch full of vegetation and water, chainage 2730m.

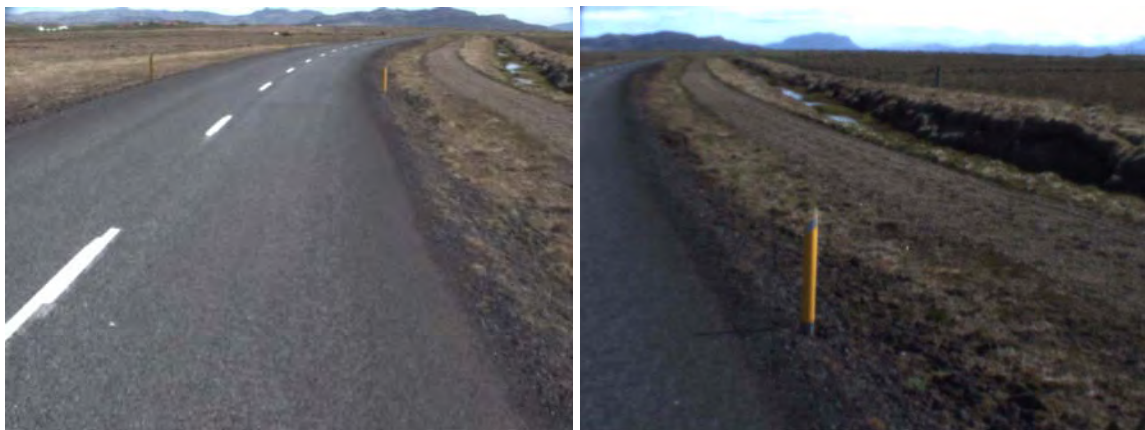
Figures 27: Water standing in the ditch behind the horse track, chainage 6300m-6500m.

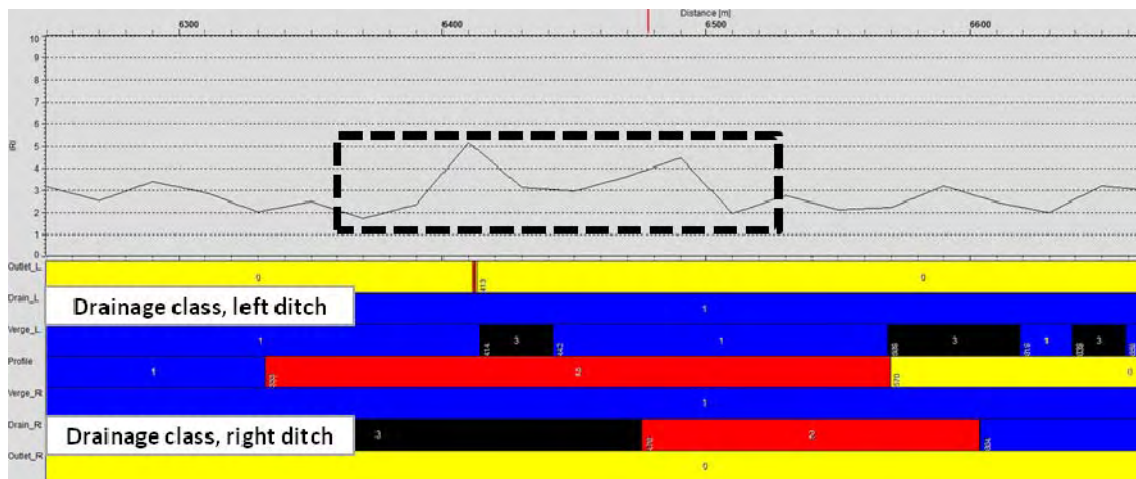
Figure 28: Higher IRI values at chainage 6400m-6500m, where water was standing in the ditch behind the horse track.

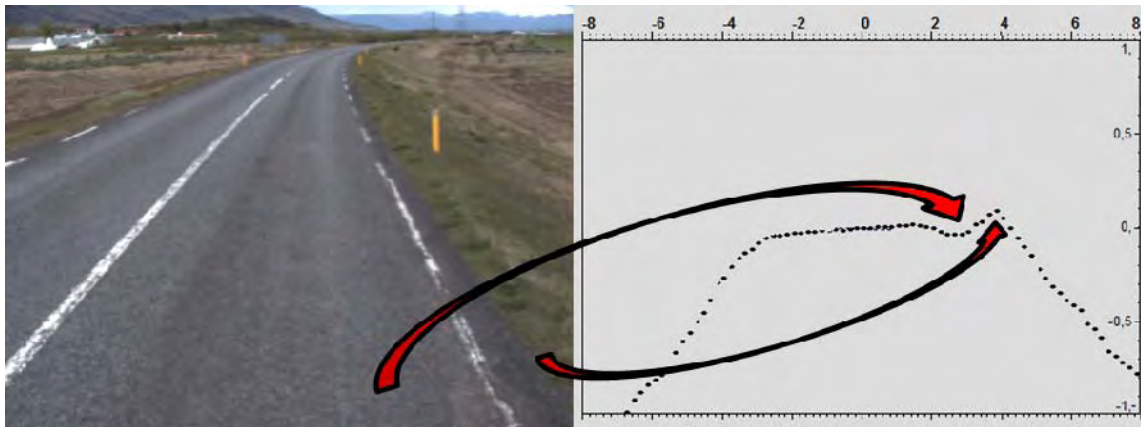
Figure 29: Deformation in the laser scanner cross section view at chainage 60m.

On section 1 there were only a few lengths where the drainage condition might need some attention. In most of these cases the verge should be removed (Figure 29), but in the last part of the section some of the ditches would work better if they were cleaned also (Figure 30).

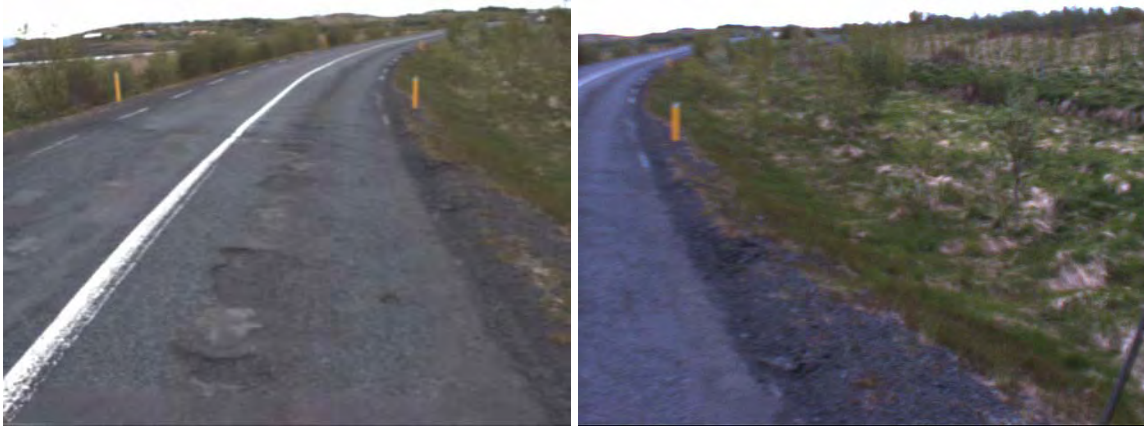
Figures 30: Inadequate drainage on the upper side of the side sloping profile. Left figure is the road camera view and the right figure is the ditch camera view, chainage 8810m.

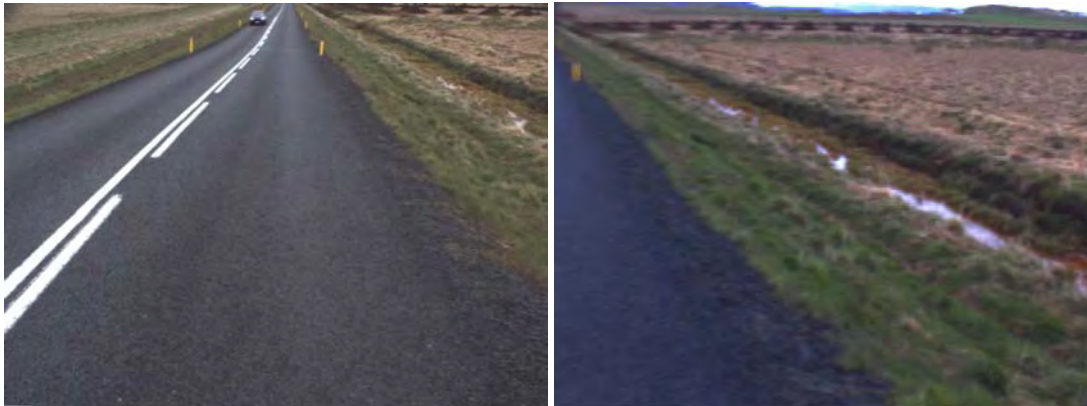
Figure 31: Water stays in the ditch on the left side, left figure is the road camera view and the right figure is the ditch camera view (chainage 1090m from direction 2).

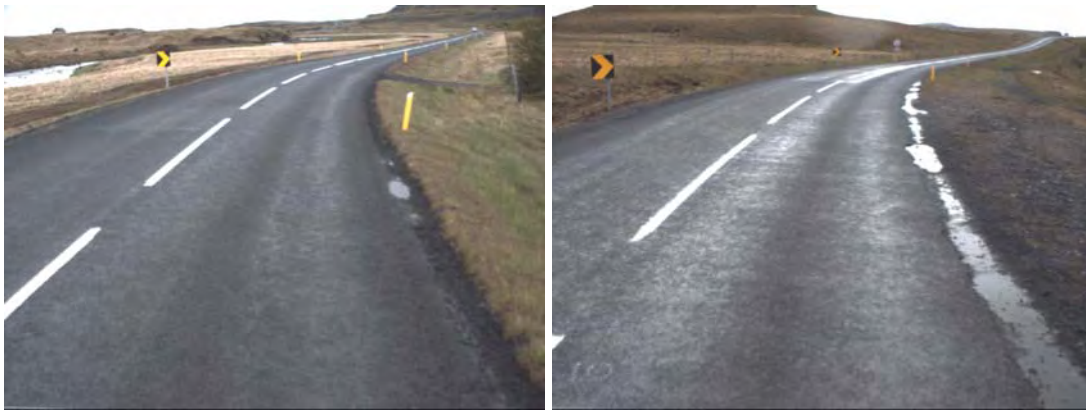
Figure 32: Verge preventing the water flow, chainage 6520m and 6760m.

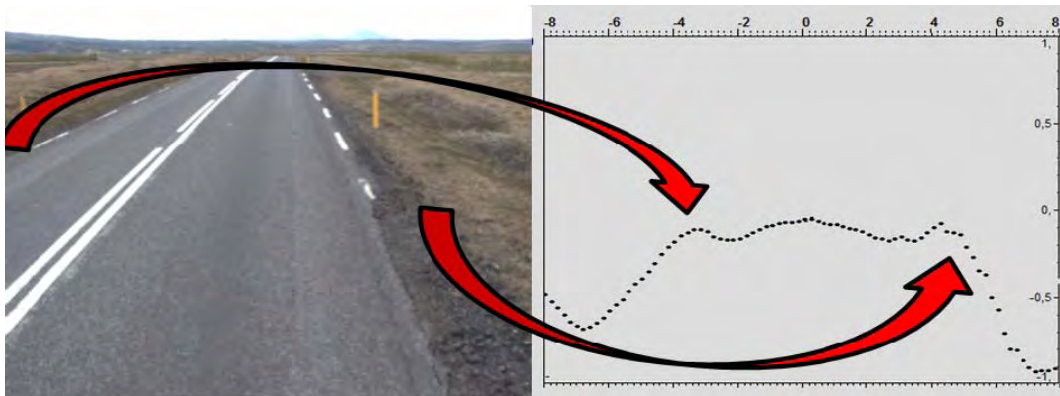
Figure 33: Shoulder deformation on both sides of the road (chainage 2240m).

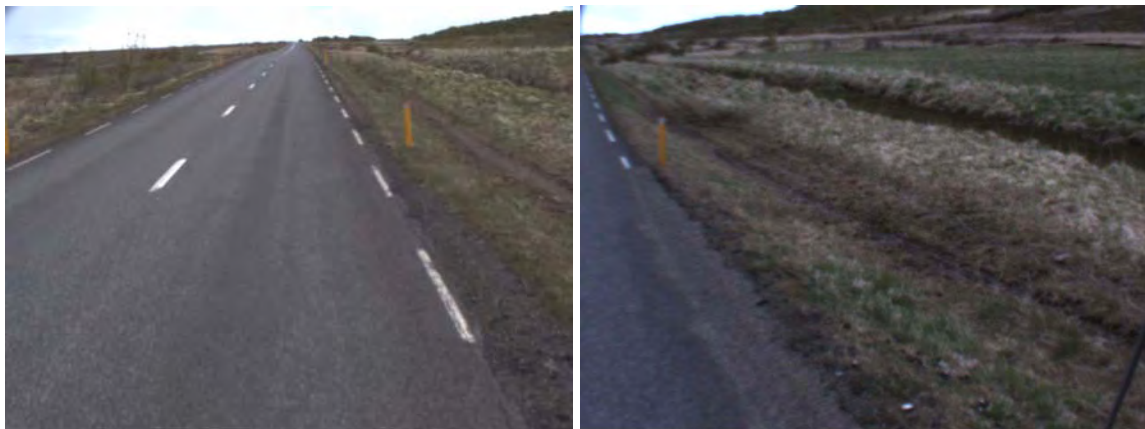
Figure 34: Water is standing in the ditch bottom, the left figure is the road camera view and the right figure is the ditch camera view at the same chainage (chainage 2290m).

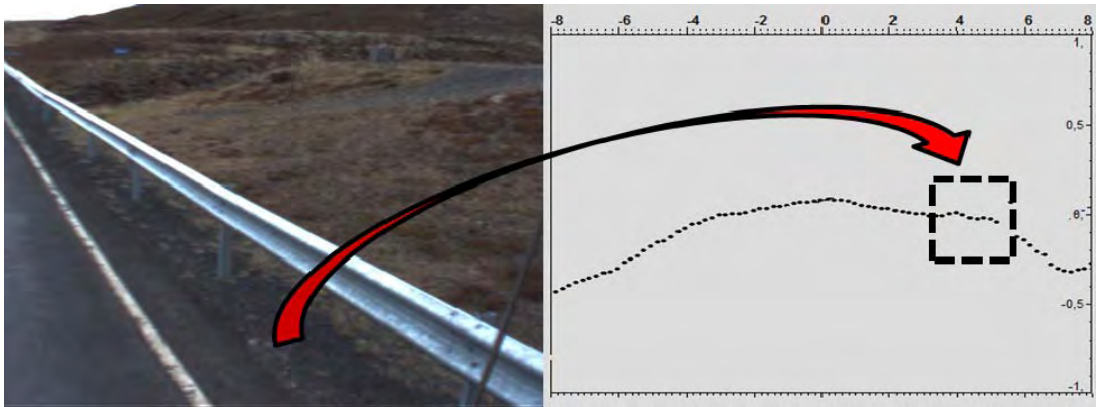
Figure 35: Minor deformation under the guardrail at 4750m.

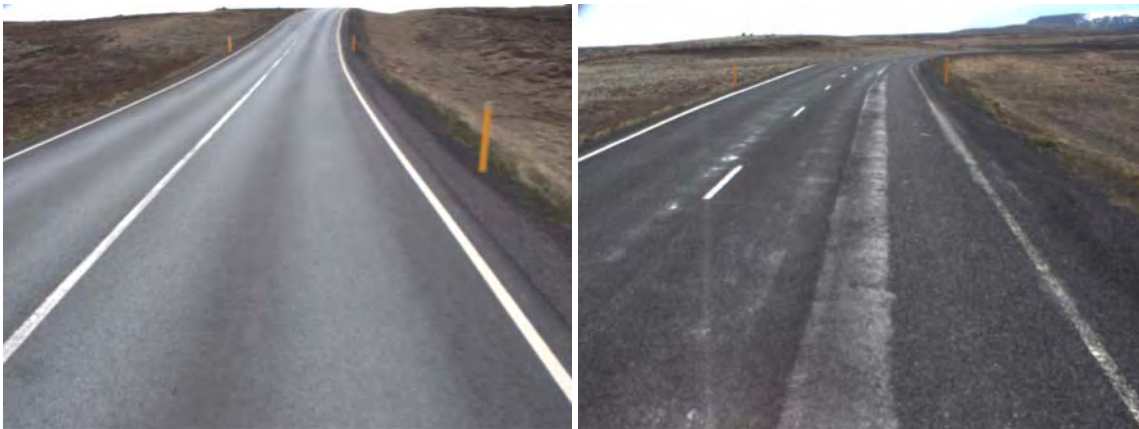
Figure 36: In road 36 section 07 the pavement condition varied but there were no drainage problems (chainage left 600m, right 2700m).

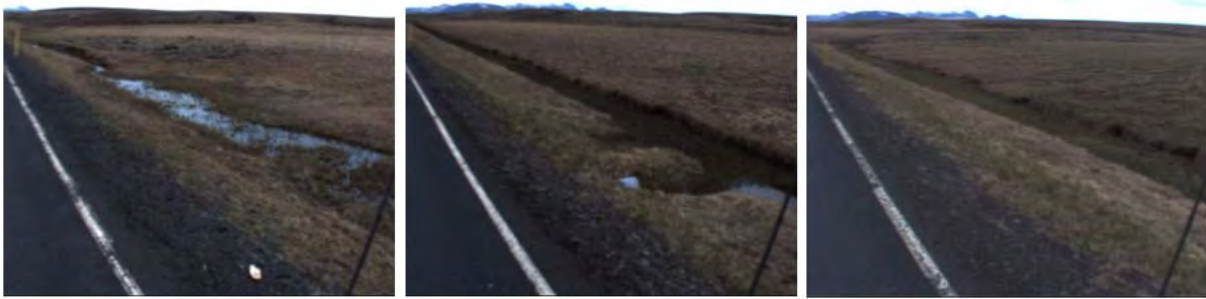
road condition (Figures 37). A couple of short lengths with minor verges were also found especially in the beginning of the section.

Figure 37: Water standing in the ditches in section 08 but the road is on high embankment, chainage from left to right: 650m, 1120m and 1410m.

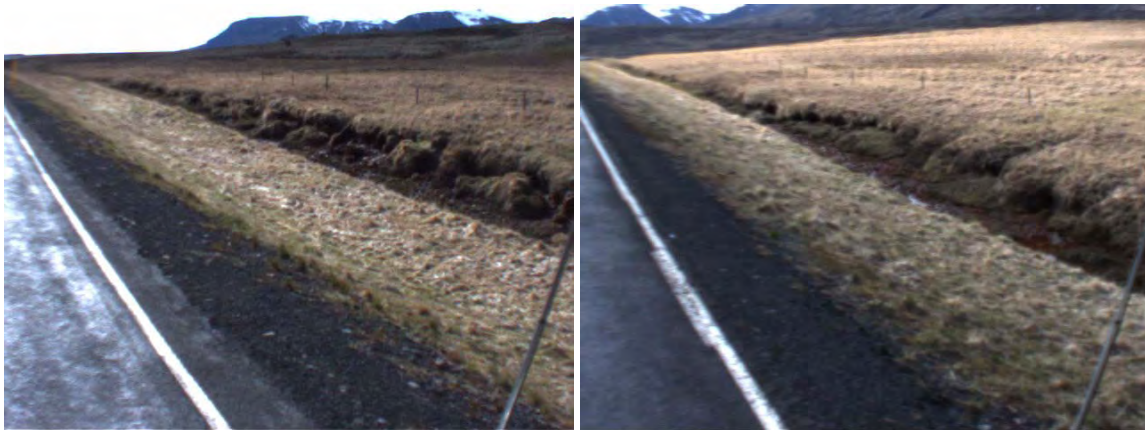
Section 11 of road 36 continued from the end of the previous 08 section. The length of the section was 7990m. In the right ditch there were a few lengths where unstable material had partly filled the ditch (Figures 38) and this was clearly hindering the water flow. Cleaning of the ditches could be problematic however as the local soil type is peat. These drainage deficiencies did not seem to have an effect on the visual road pavement condition. IRI data was not available for this section.

Figure 38: Unstable material was hindering water flow in the ditch (chainage 480m and 890m)

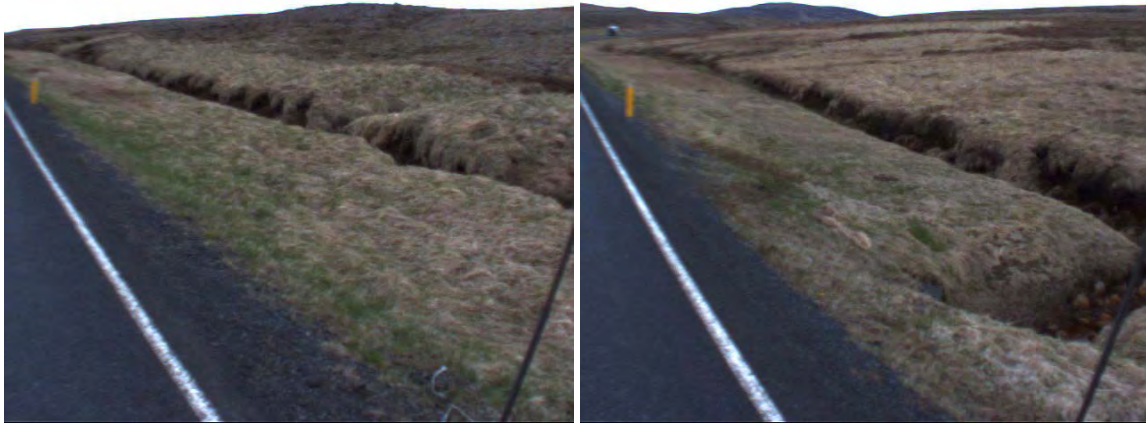
On the left side of the section from 4500m to 5600m the road was on a side sloping road profile and the left side was the upper side. The ditch was more or less filled with collapsed material from the ditch walls resulting in standing water in the ditch. Normally this kind of drainage defect would have caused consequential problems for the road, but on this section this was not apparent (Figure 39). One reason could have been that even though there was water standing in the ditch, the level of water in relation to the road structure was low, and also there were several culverts which seemed to work well. Verges were not a problem on this section.

Figure 39: Collapsed ditch walls on the upper side of the road profile at 4690m and 5450m.

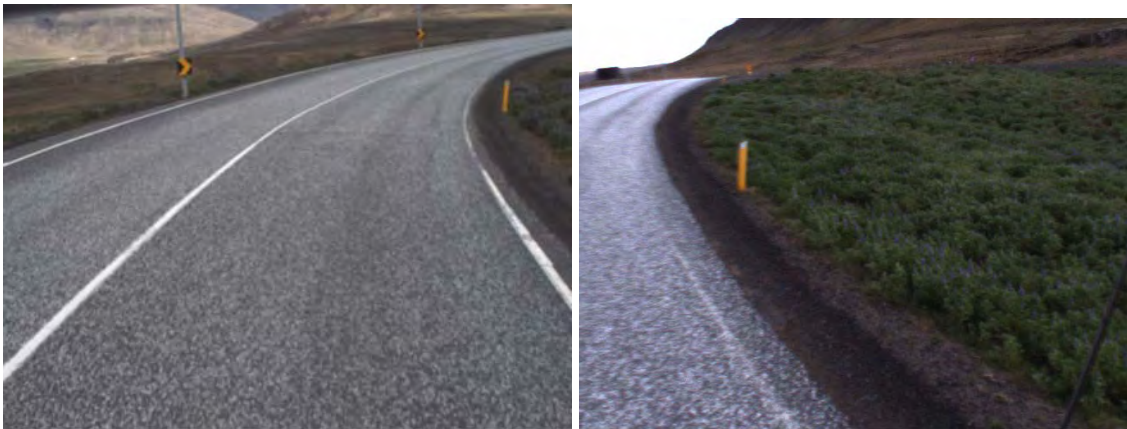
Section 12 of road 36 was surveyed from the end point of section 11 to the roundabout at road 1, a length of 7190m and the prevailing road profile on the section was side sloping ground (52.5%). The drainage was working mainly well on this section. In the middle part there was a section (3700m- 4900m) where the right ditch was shallow and filled with vegetation, but this had not affected the visual condition of the road. IRI data was not available for this road section. The side sloping cross profile became steeper near the end of the section and the drainage system was insufficient in the upper side of the slope (Figure 40).

Figures 40: Insufficient drainage on the upper side of the steep side slope at chainage 6900m. The left is the road camera video and the right is the ditch camera video.

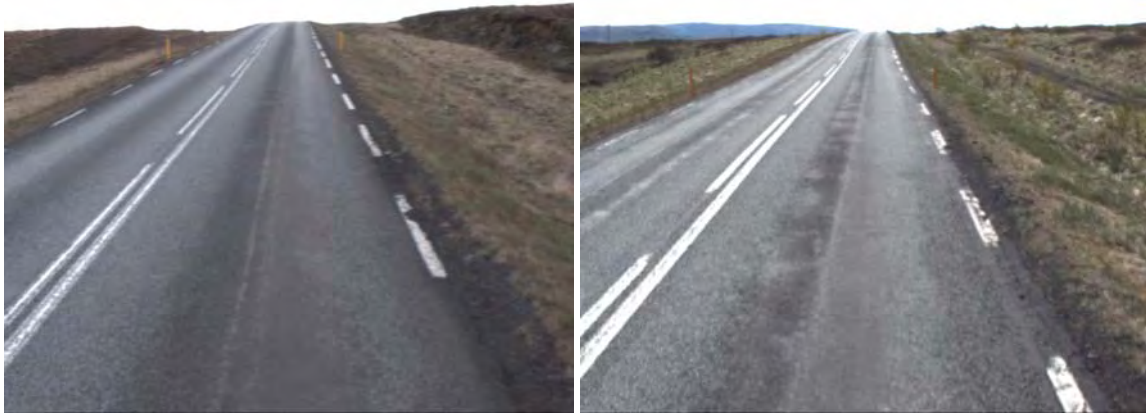
Figure 41: Examples of verge, chainage 8450m (left) and 10640m (right).

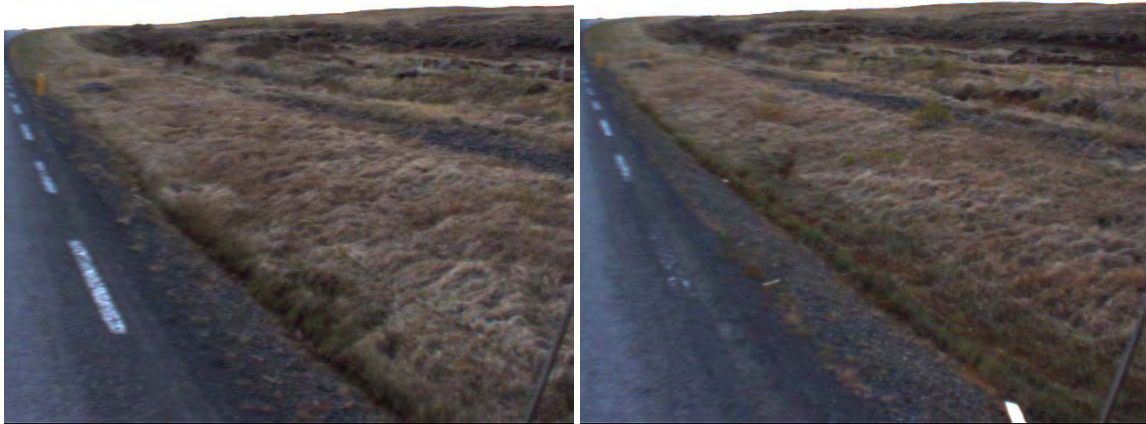
Figures 42: Water lying between the road and the horse track (chainage 7990m, 8010m).

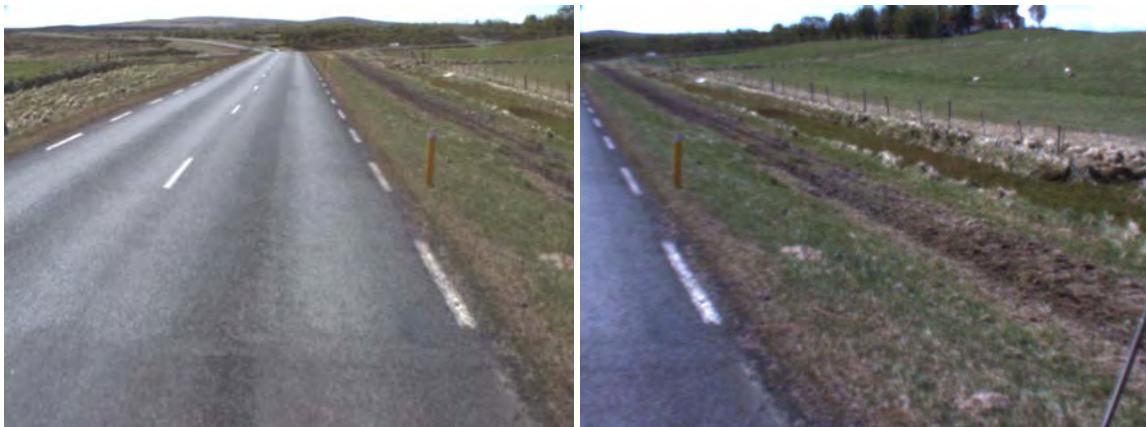
Figures 43: Ditch filled with vegetation and water. Left figure is the road camera view and the right figure is the ditch camera view, chainage 11480m.

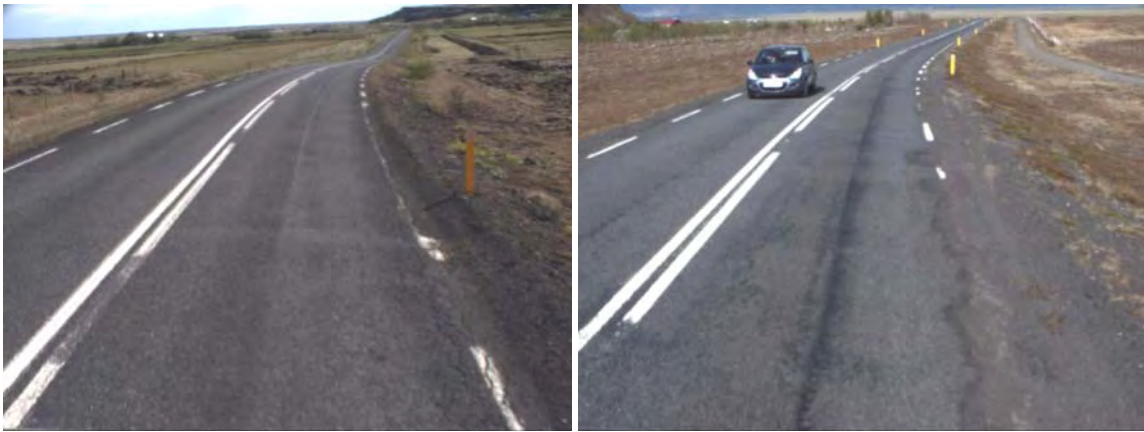
The few drainage shortages found were due to the presence of verges (Figure 45). On the right side from 3300m to 3400m some bush clearing had been carried out and at the time of the survey there was still debris lying in the bottom of the ditch.

Figures 45: Verge was preventing the water flow from the pavement surface at times (chainage 4030m on the left, 11090m on the right).

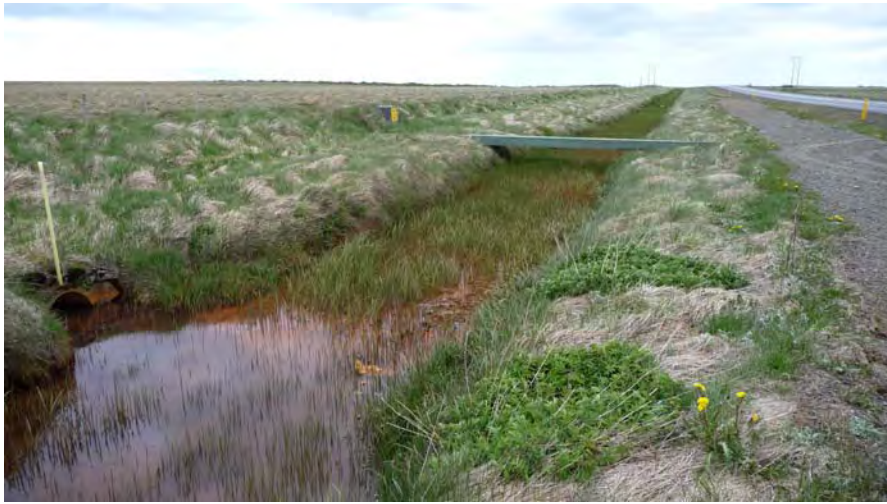
From chainage 4150m to 5050m, water was standing in the ditch mainly on the right side of the road (Figure 46). The terrain was generally flat in the area and the main problem was caused by outlet ditches which were not working properly (Figure 47). However improving these ditches could be challenging to find an outfall as the area is so flat. A horse track had been constructed between the ditch and the road and this could have actually helped the drainage condition for the road as it was keeping water further from the road than a normal roadside ditch. There were no extra damages in the pavement and the IRI was average for the section.

Figure 46: Ditch full of water and vegetation at chainage 4380m.

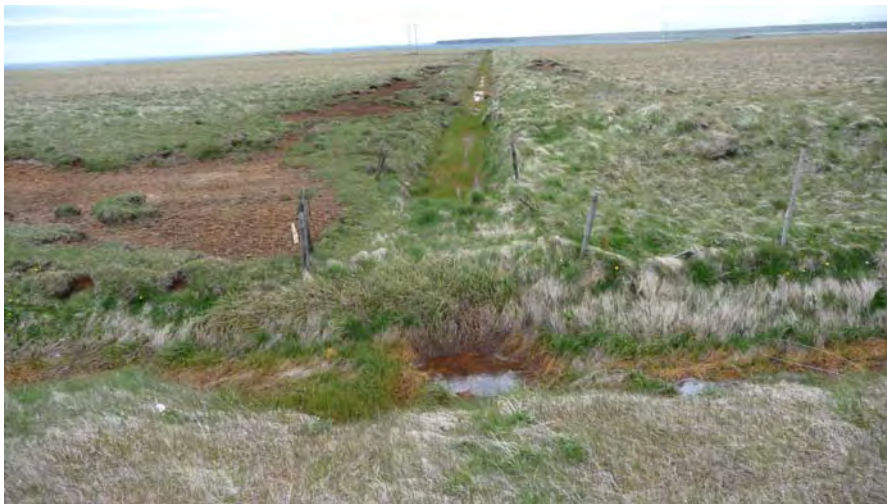
Figure 47: Blocked outlet ditch at chainage 4370m

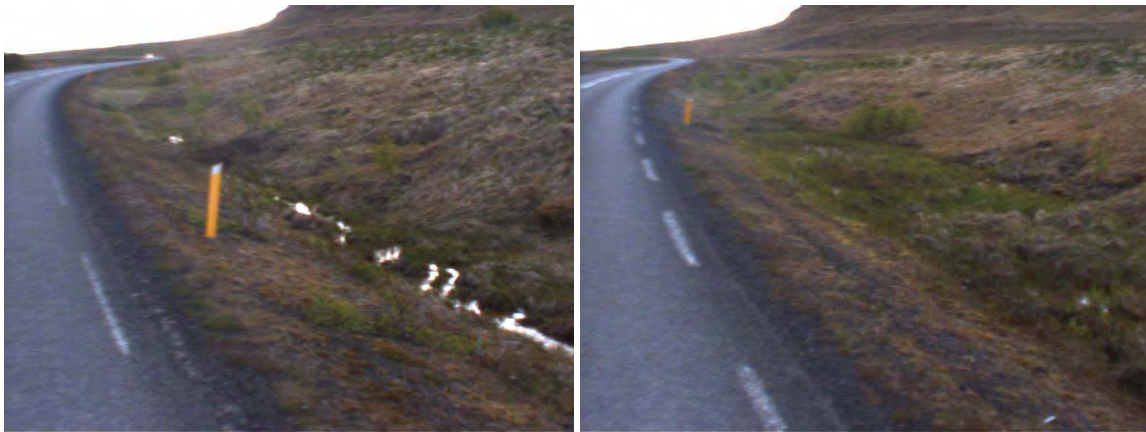
Figure 48: Unstable material on the bottom of ditch was hindering the water flow (chainage left: 7850m, right: 7890m).

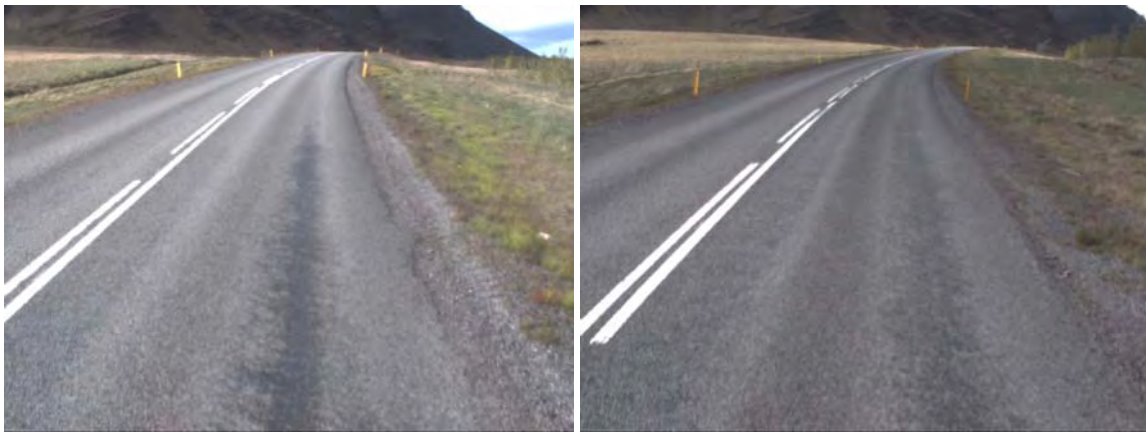
Figure 49: Minor verge at chainages 10220m and 10340m.

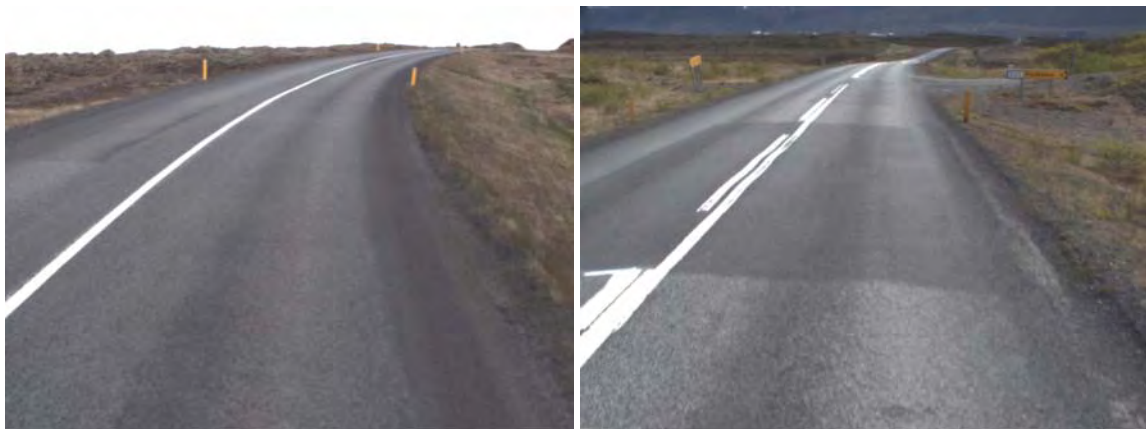
Figure 50: Example figures of verge at chainage 1270m and 2690m.

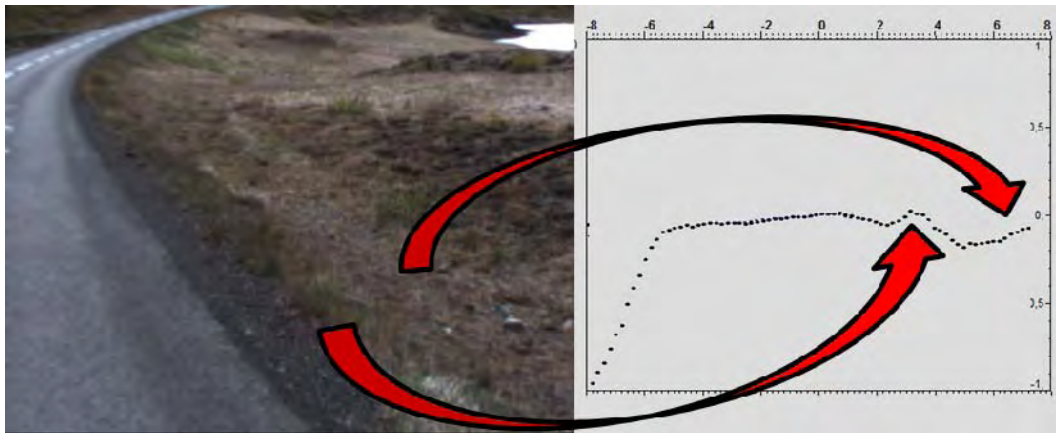
Figure 51: Shallow ditch (upper arrow) and verge (lower arrow) in laser scanner cross section, chainage 5760m.

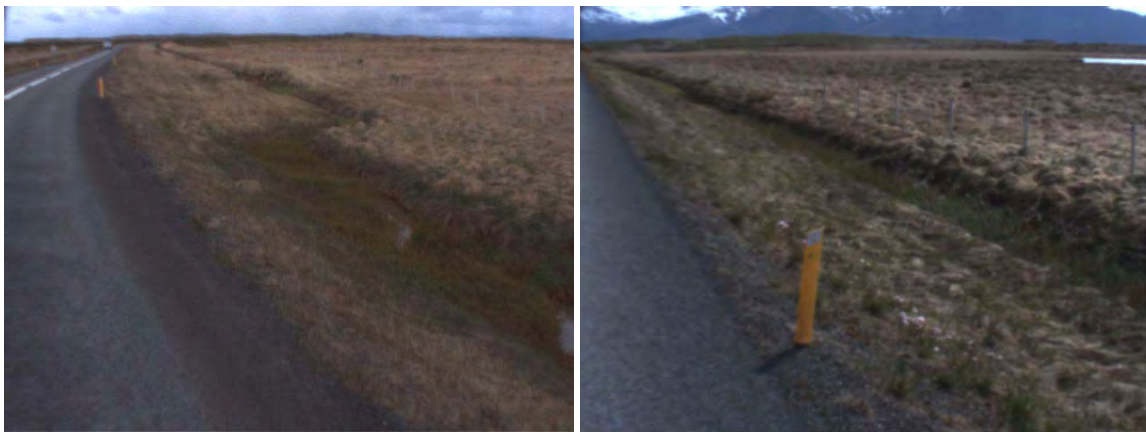
Figure 52: Water standing in the ditches (chainage left: 6760m, right: 7020m).

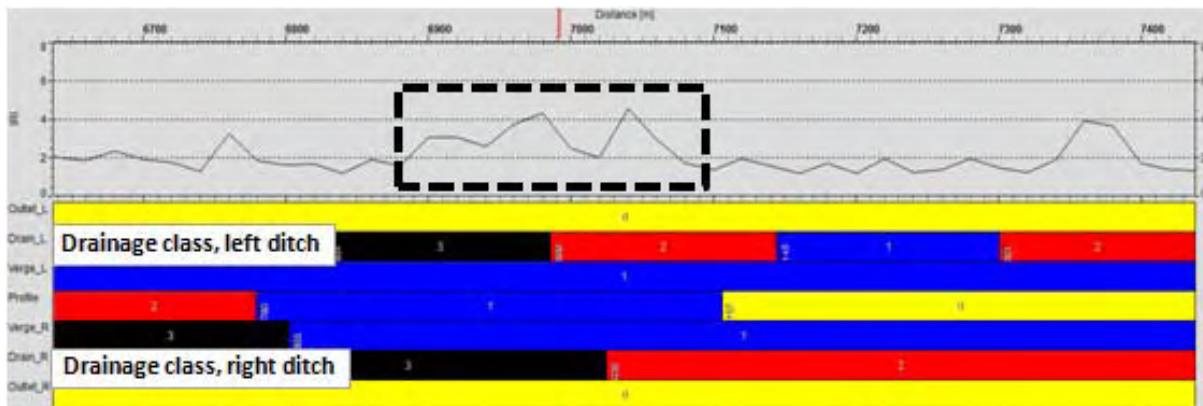
Figure 53: Higher values in the IRI data on the same section as shown in Figure 52.

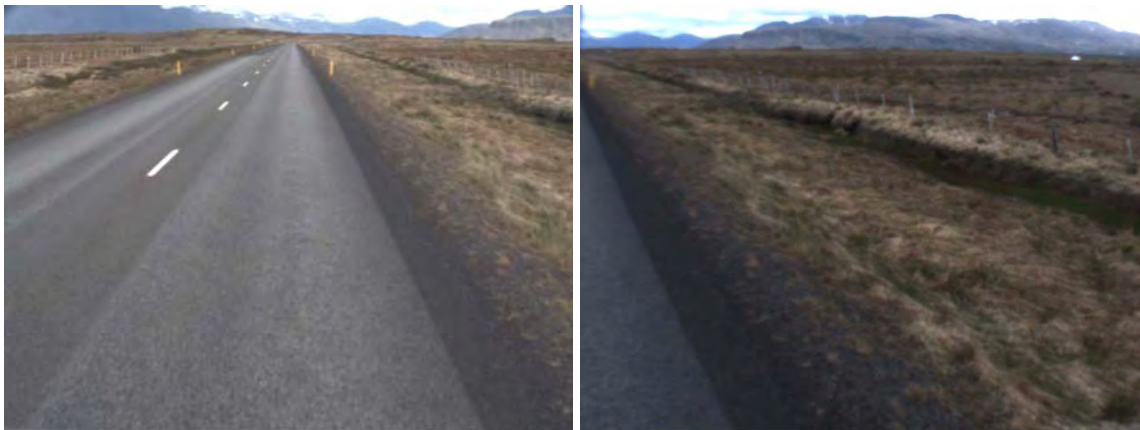
Figures 54: Water and vegetation in the ditch, chainage 1740m. The left figure is the road camera view and the right figure is the ditch camera view.
