ROADEX

Innleiðing

Rannsóknarráðstefna
Vegagerðarinnar í Hörpu
9. nóvember 2012

Haraldur Sigursteinsson
Vegagerðarin,
Veghönnunardeild

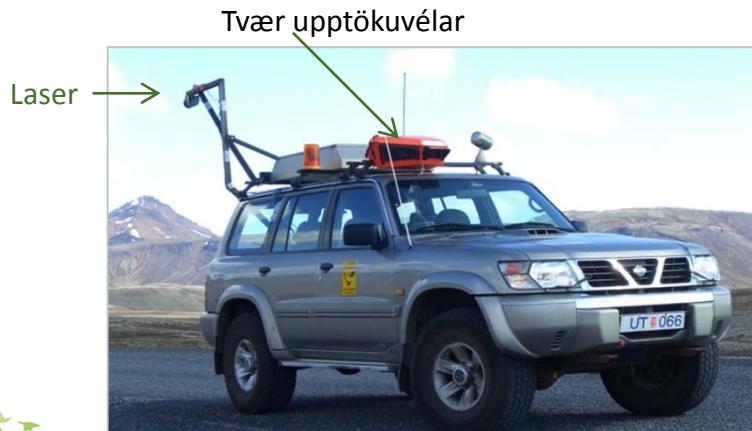
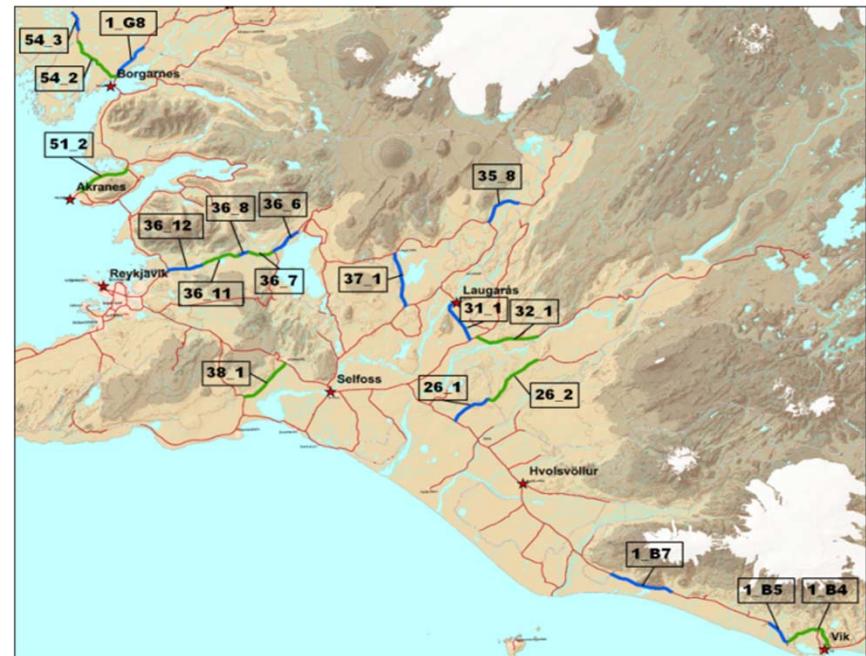
Gerð var úttekt á um 175 km af vegum og eru þessir kaflar sýndir á meðfylgjandi mynd.

Sérstaklega var óskað eftir vegum þar sem afvötnun var talin ábótavant.

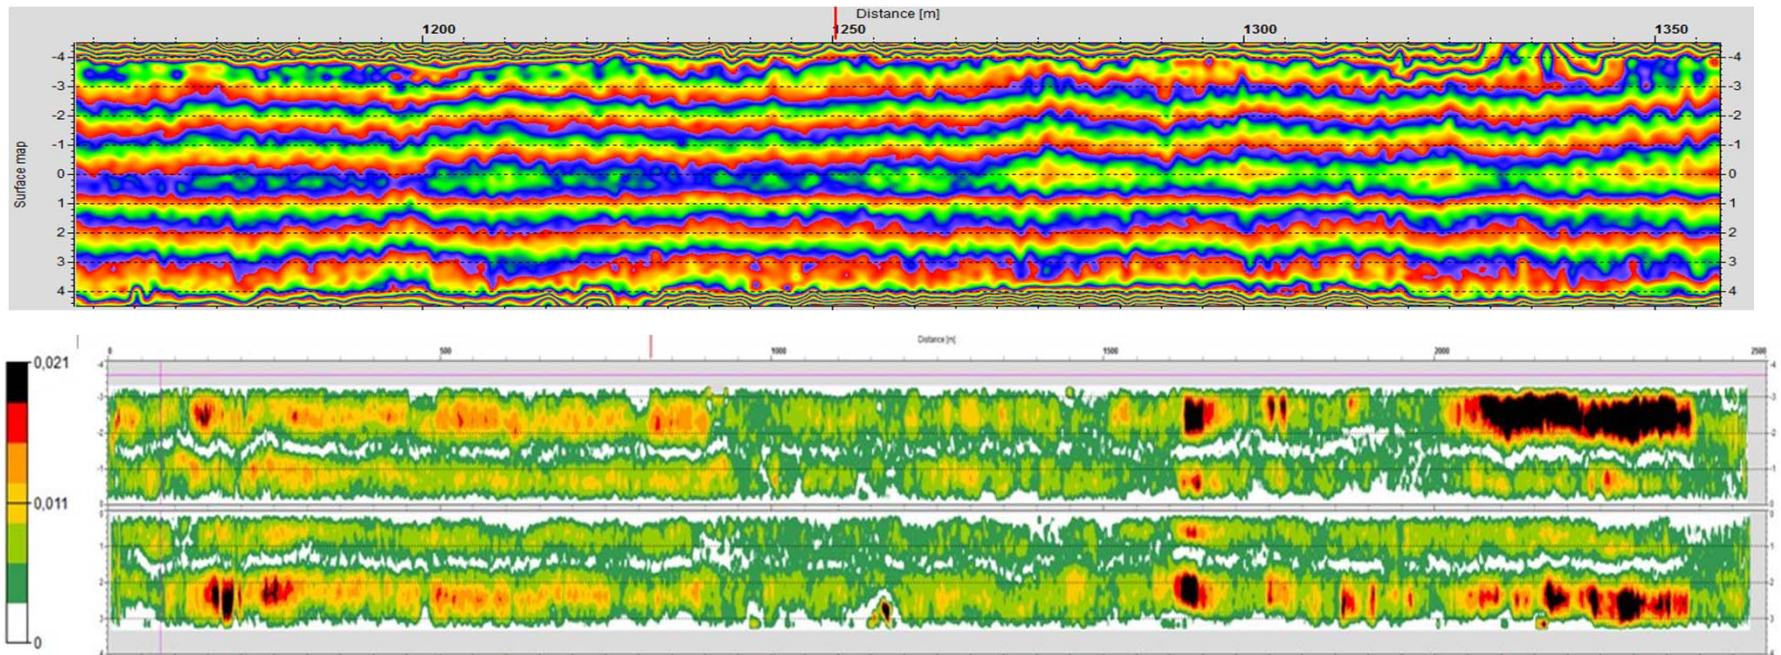
Bifreið Vegagerðarinnar var útbúin sérstaklega fyrir verkefnið. Smíðaður var rammi fyrir laserskannann og var hann staðsettur aftan á bílnum í um 3 m hæð frá jörðu.

Við úrvinnsluna er notaður hugbúnaðurinn Road Doctor

Regnbogakort er teiknað af yfirborði vegarins, hér er góður rishalli á veginum en litaskipti verða við hverja 40 mm í hæðarbreytingu.

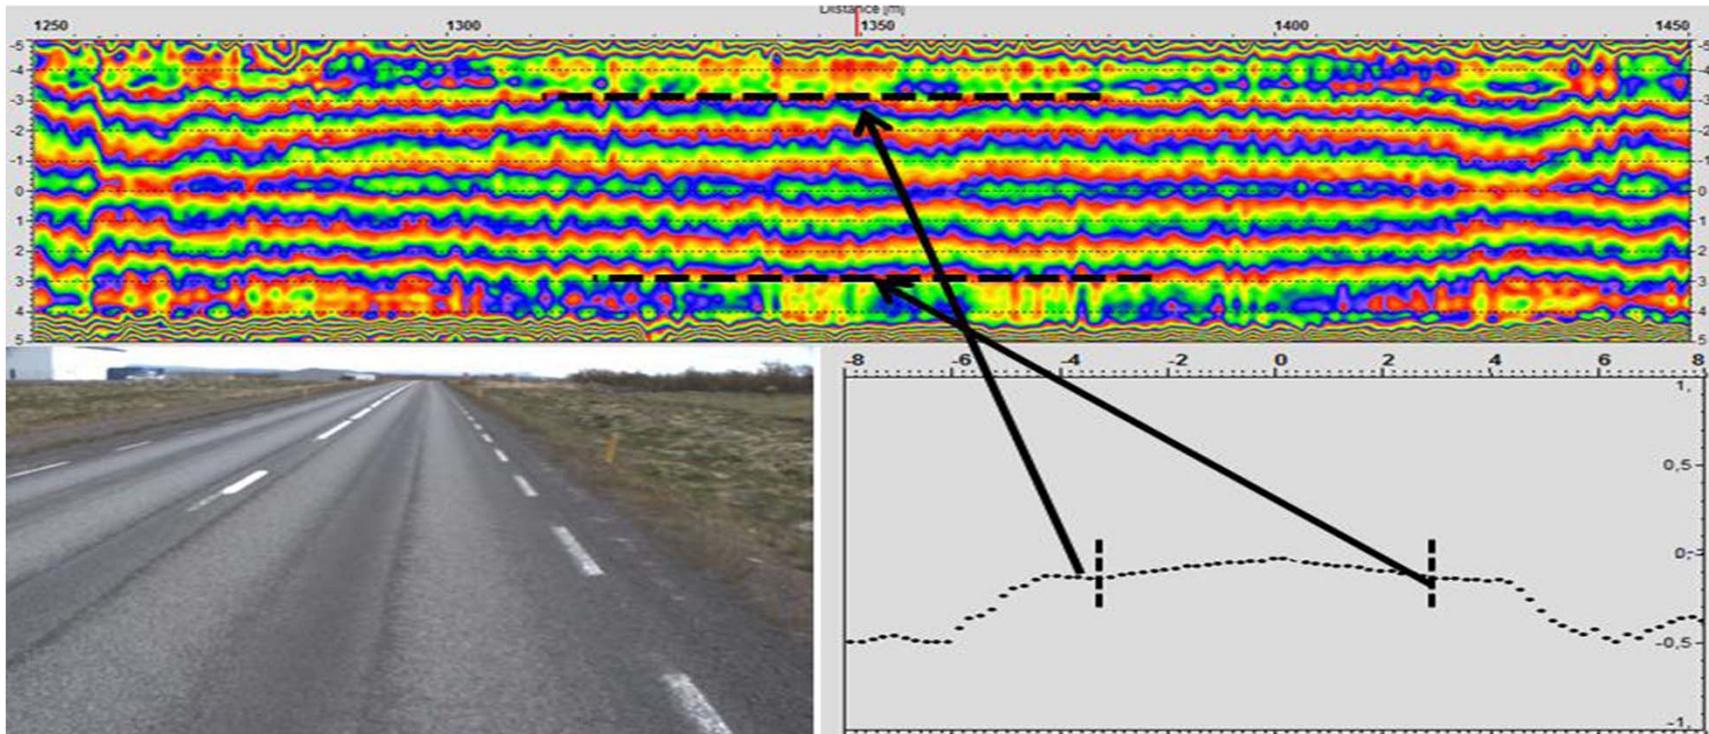
Nýr úrvinnslumöguleiki er að mögulegt verður að teikna upp hjólför og aðrar formbreytingar á sama hátt.

Vesturlandsvegur ofan við Borgarnes. Hjólför við axlir koma fram sem breiðir fletir á regnbogalínuritinu.

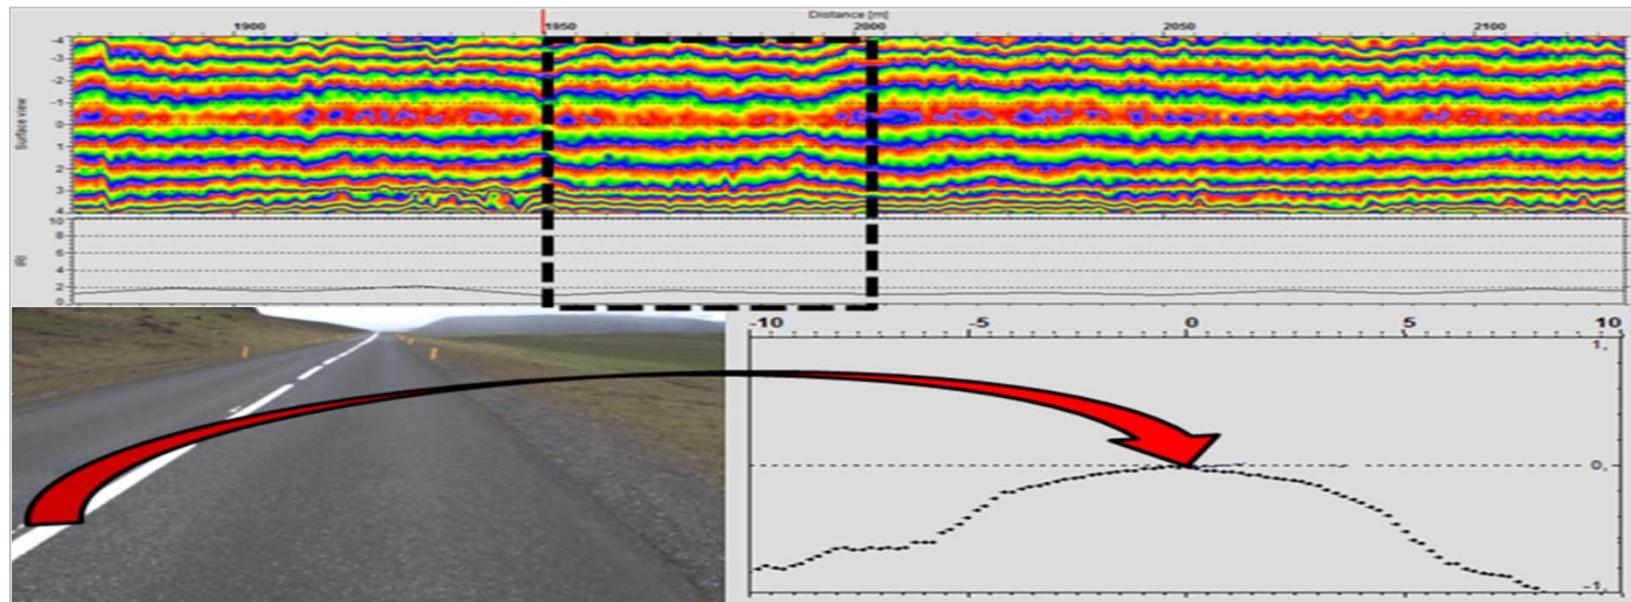
Regnbogakortið er notað til úrvinnslu ásamt myndum og þversniðsteikningum sem gerðar eru út frá lasermælingunum.

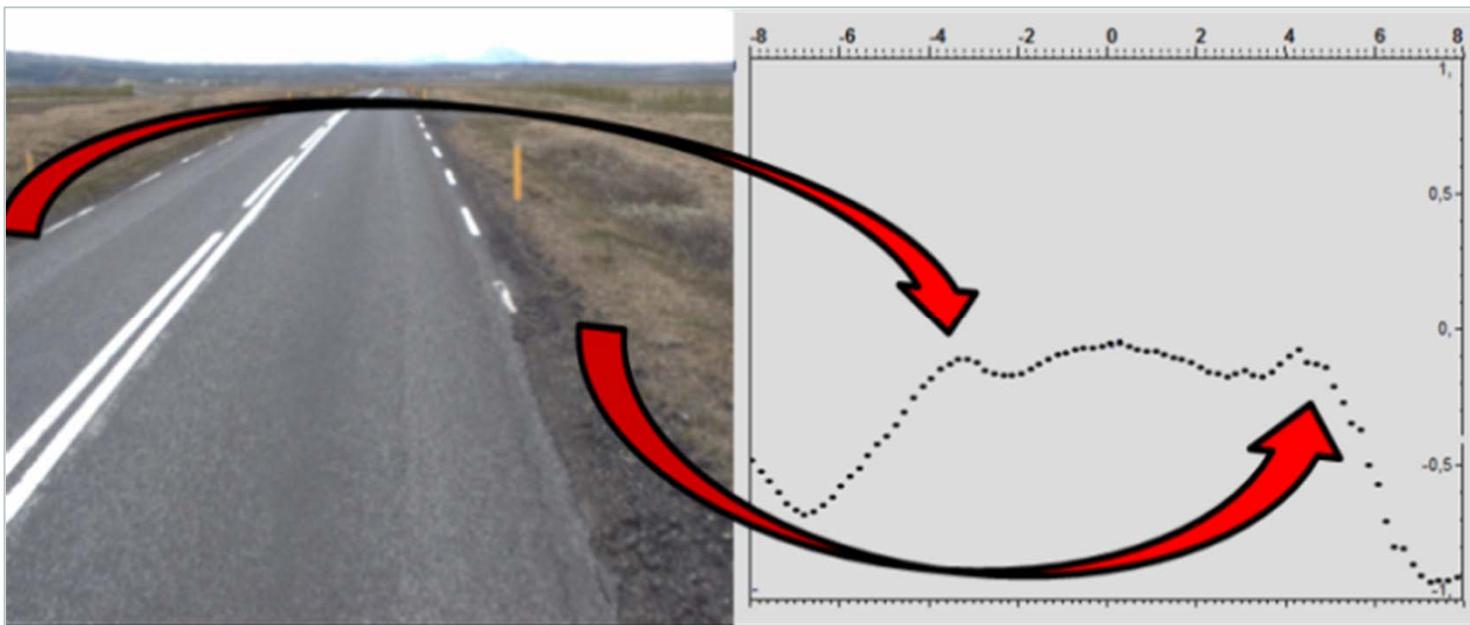
Dæmi um veg á Suðurlandi með góðum rishalla .

Það voru ekki allir vegir vel krýndir.

Helstu athugasemdir sem koma fram í úttektinni voru vegna rása og hárra kanta.

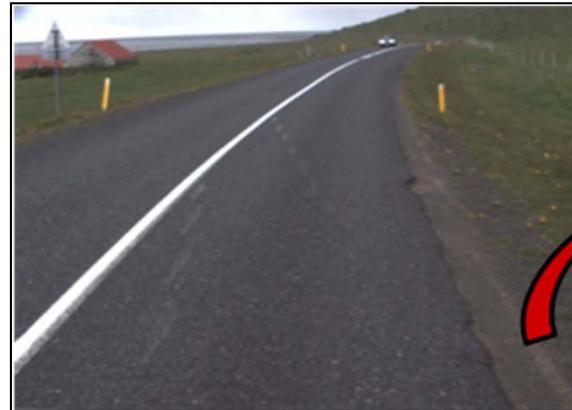
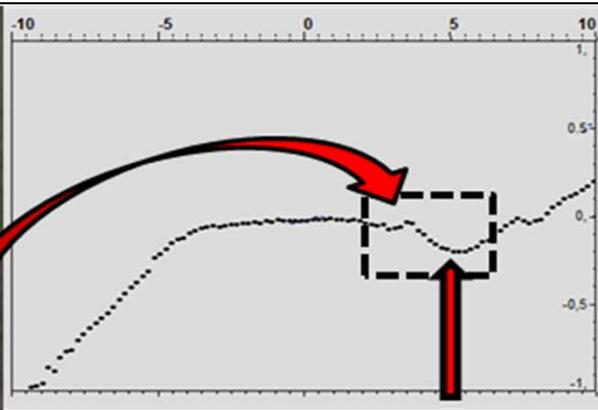
Grunn vegrás og
uppgróin axlarbrún,
tvær ástæður fyrir því að
vatn leitar inn í veginn.

Skurðir fullir af
vatni og gróðri
geta haft áhrif á
sléttleika

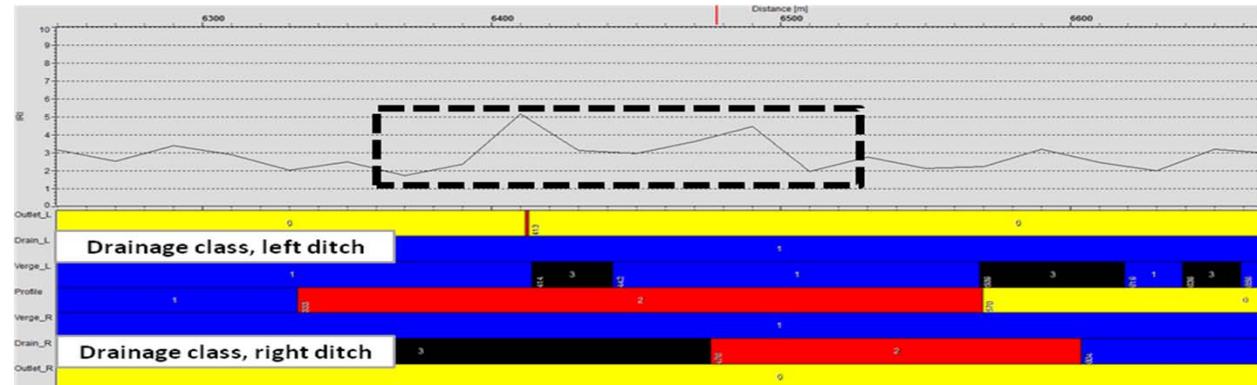
Vegkaflinn lendir í afvötnunarflokk 3 og hefur talsverð áhrif á sléttleikann sbr. hækkun á IRI gildi.

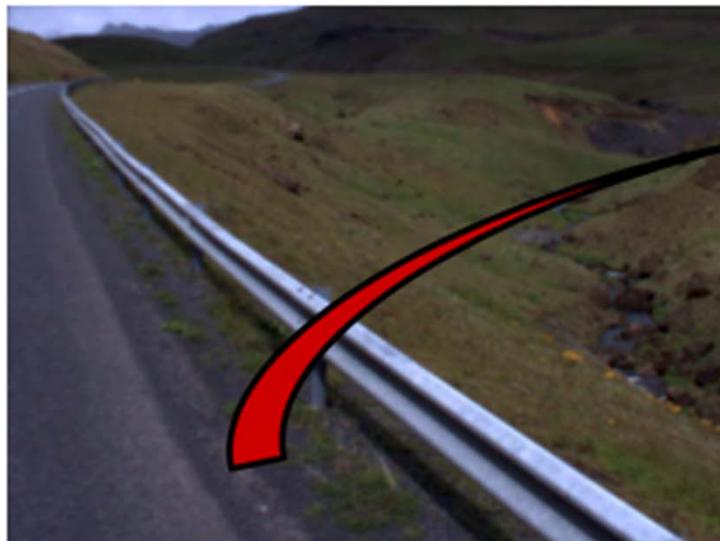
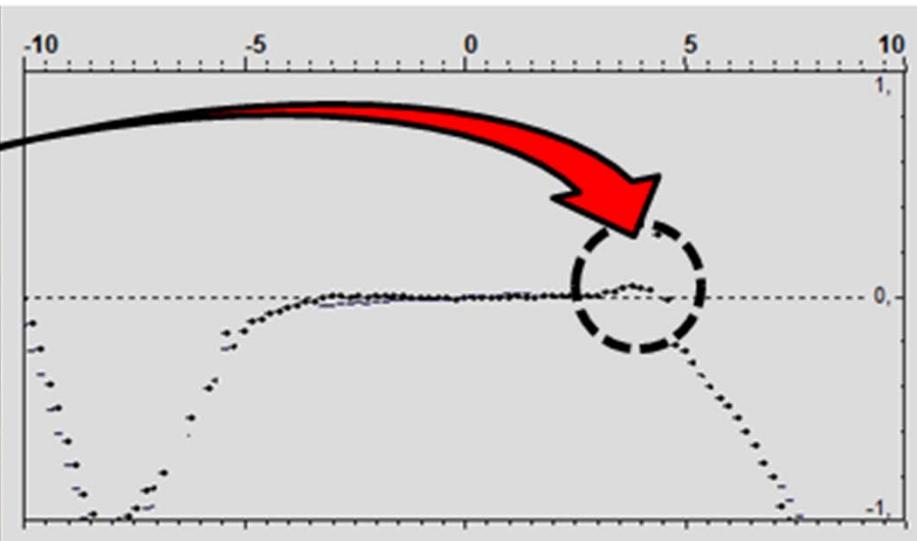
Röst undir vegriði

Verður til þess að vatn leitar inn í burðarlagið.

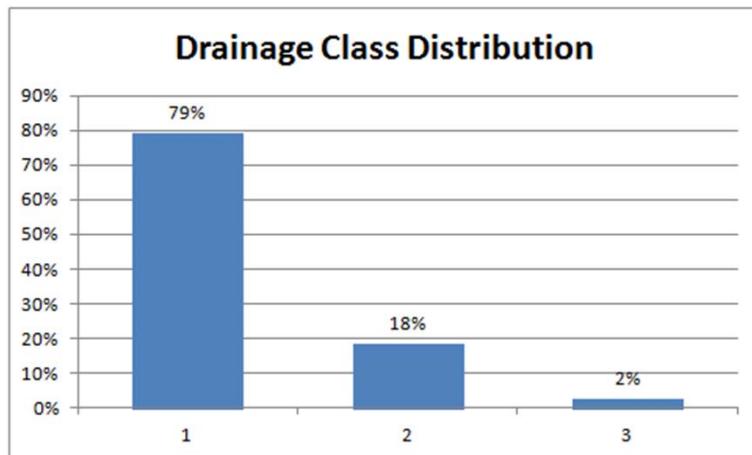
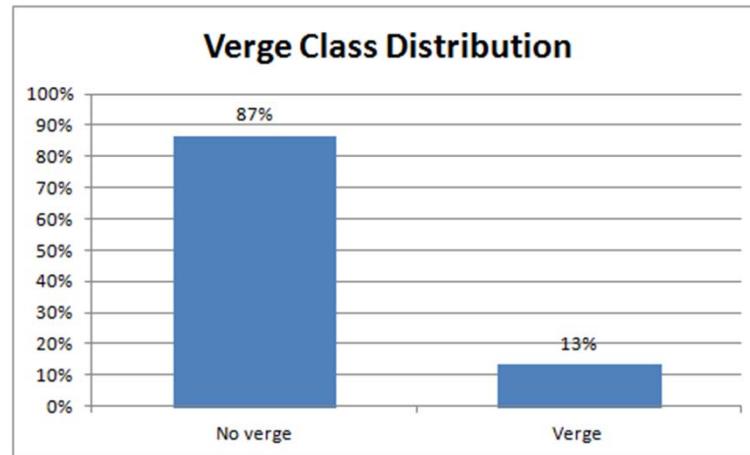
Meirihluti vega í greiningunni var byggður á fyllingu eða 57% sem er hærra hlutfall en hjá öðrum.

Afvötnun er flokkuð í þrjá flokka: 1 – góð, 2 – ásættanleg og 3 – léleg.

Rastir á vegöxlum eru flokkaðar í two flokka: 1 – engar rastir, 2 – röst er til staðar.

Miðað við afvötnun lendir verulegur meirihluti í flokki 1 eða 79% og rastir á köntum eru á 13% þeim vegum sem voru mældir.

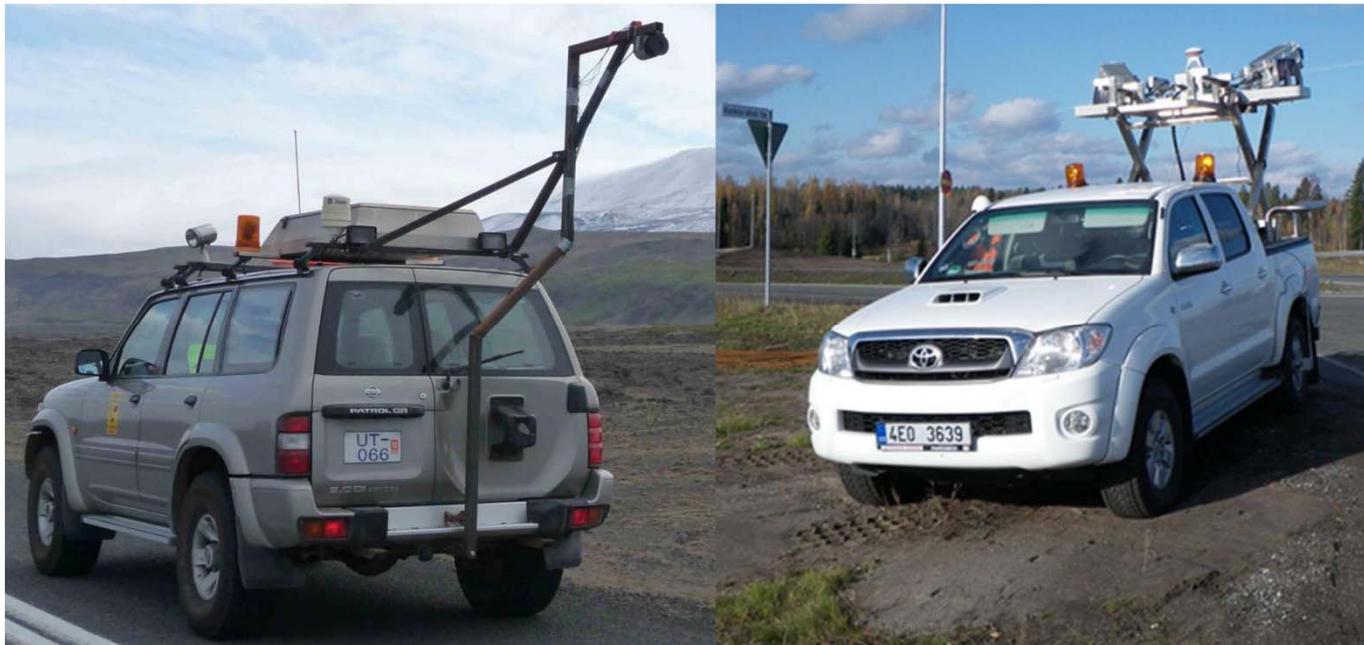
Everyman's RDLS Laser scanner survey vehicle (left)
and a high precision Quantum 3D laser scanner survey vehicle (right) used in ROADEX surveys

Nýr búnaður með úrvinnsluforriti mun kosta á milli 5 – 8 milljónir kr. án aðflutningsgjalda.

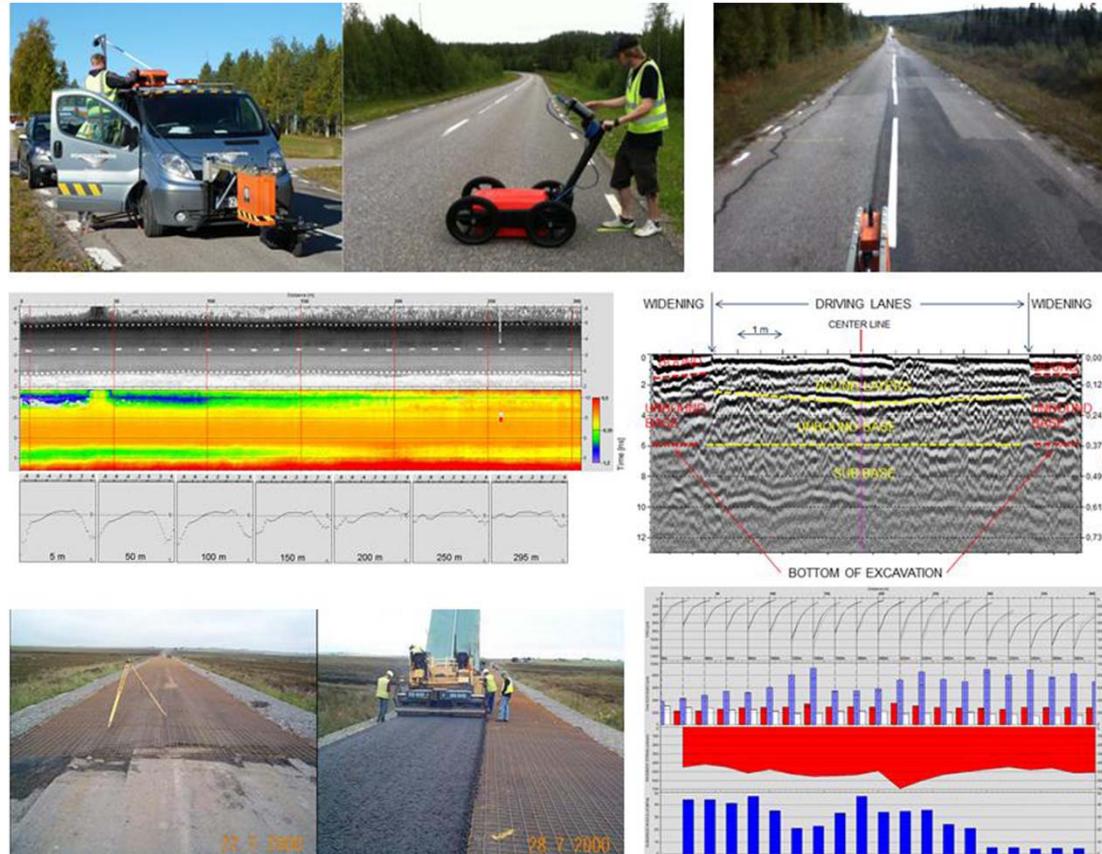
Vettvangsraðnsóknir og mat á gömlum breikkunum.

Við úttekt var m.a. notast við;

- 3d GPR mælitækni og
- háskerpu IR mælingar

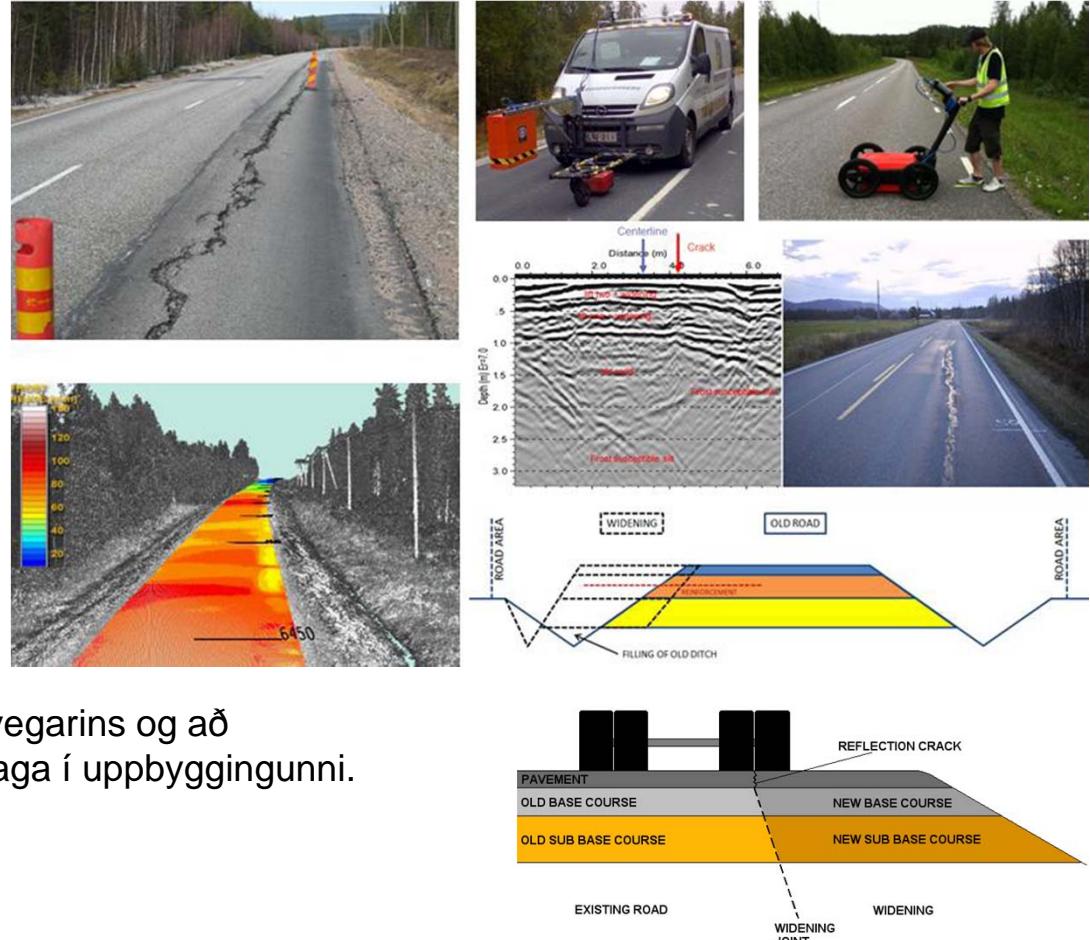
Fjallað er um undirbúning, hönnun og uppbyggingu.

Einsleitni einstakra laga í veginum.
Álag frá umferð.

Gerð og staðsetningu samsetningar.
Frágang fláa.

Áhersla er lögð á að breikkunin sé
hvorki veikari eða sterkari en aðrir hlutar vegarins og að
ekki sé mismunur á frostnæmi einstakra laga í uppbyggingunni.

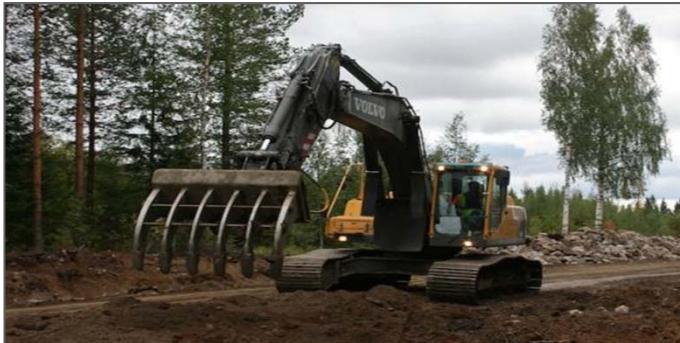
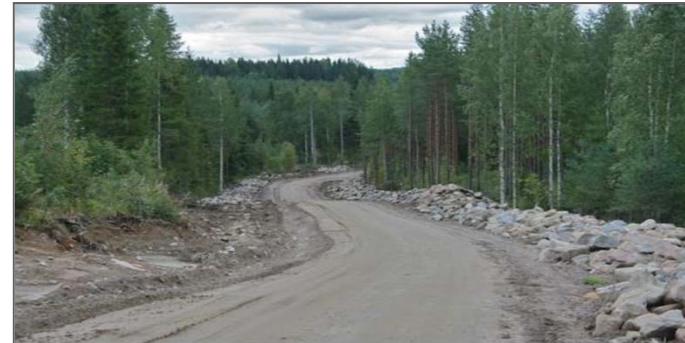
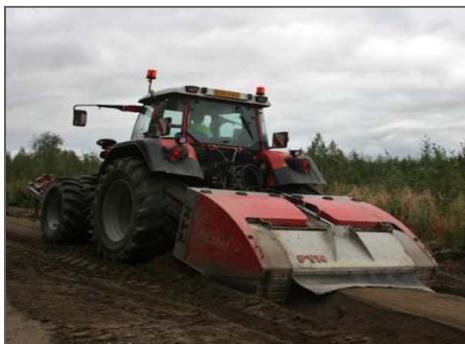
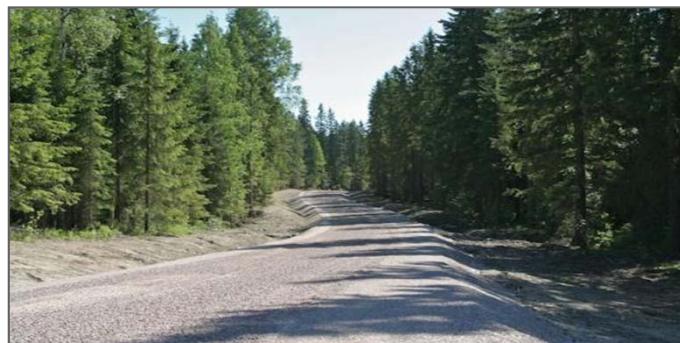
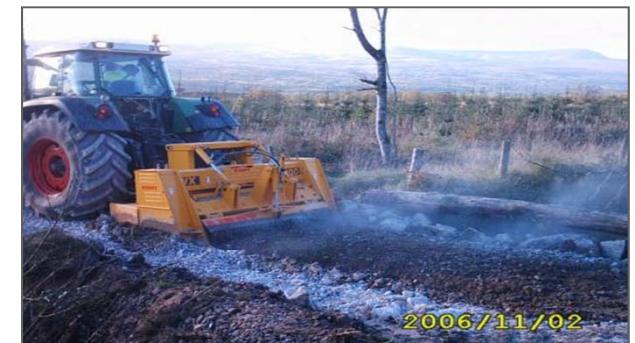
Coarsening of a roadbase by stone crushing

Steinbrjótur á Írlandi

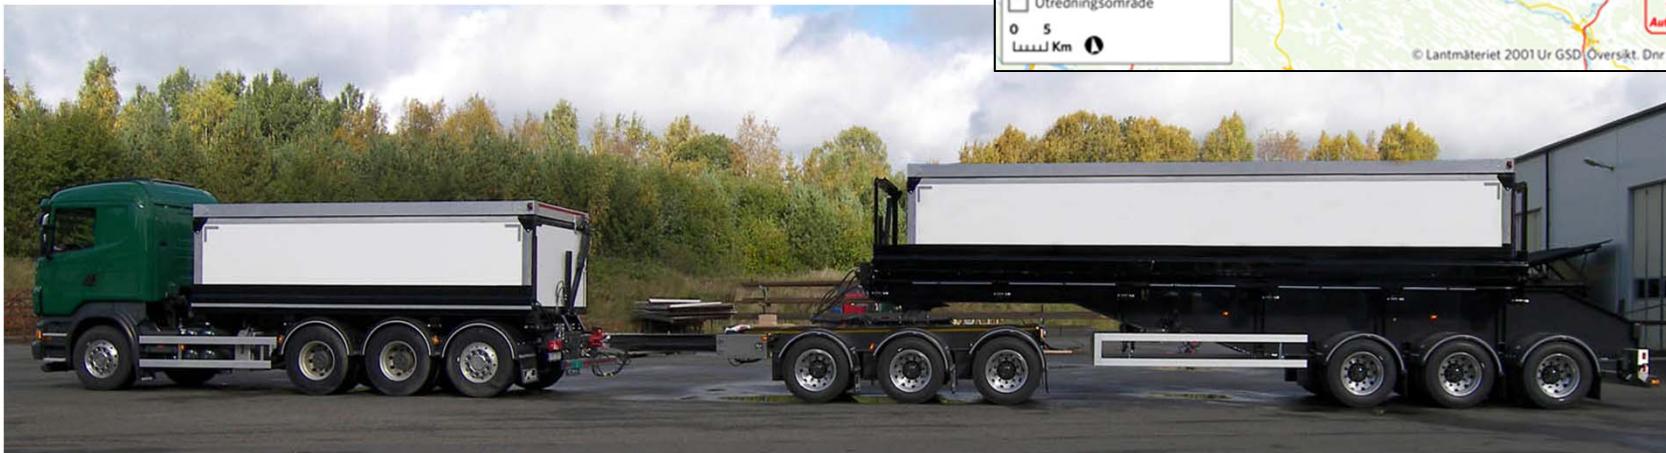
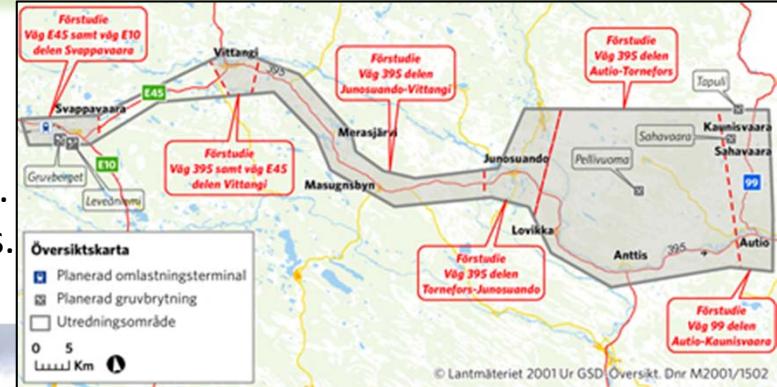
Um 150 km námuvegur í Norðurbotni Svíþjóðar.

Fimm milljón tonn af málmgrýti á ári um venjulega þjóðvegi.
60 tonna trukkar á 5 mínúta bili 24 tíma/dag alla daga ársins.

90 tonna vagnlestir, 7 mínútur á milli vagnlesta (25 m)
Hraðaminnkun í þéttbýli og yfir tvær brýr á leiðinni, 50 km

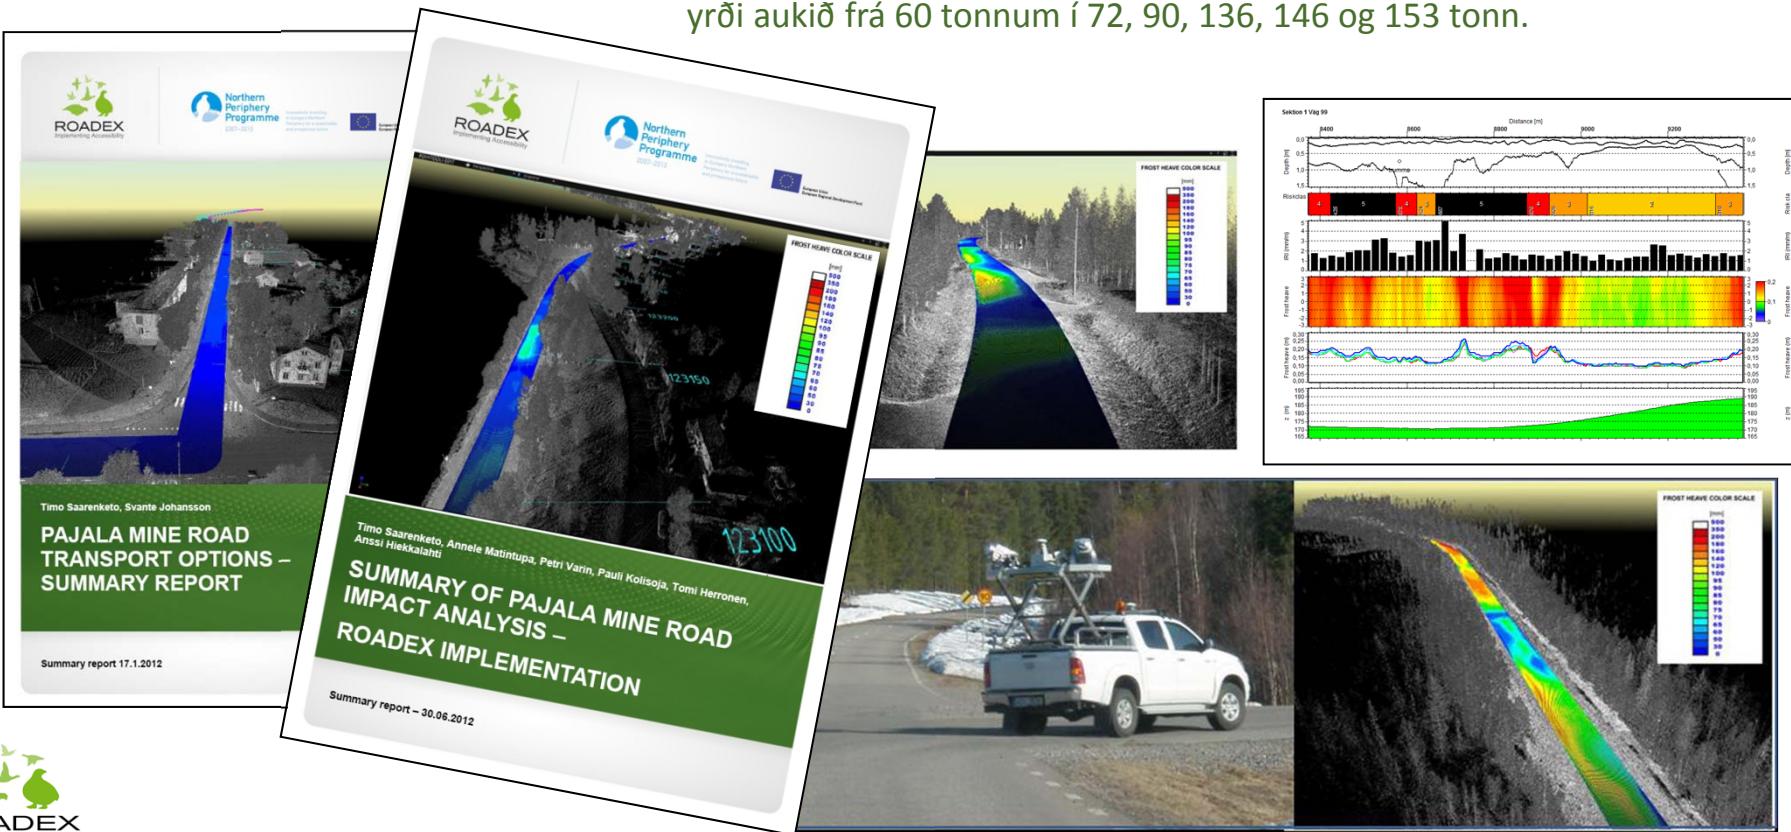
ROADEX / RoadScanners vann úttekt, áhættugreiningu og gerði tillögur um styrkingar vegna þessa verkefnis og hvað þyrfти til ef álagið yrði aukið frá 60 tonnum í 72, 90, 136, 146 og 153 tonn.
