# Framkvæmda- fréttir 11. tbl. / 16

**Framkvæmdafréttir Vegagerðarinnar 11. tbl. 24. árg. nr. 668 22. nóv. 2016**

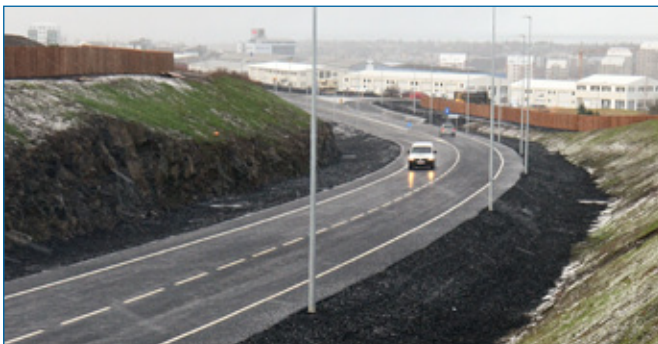
Verkið fólst í því að leggja nýjan 1,6 km langan veg frá mismögum vegamótum við Reykjanesbraut og austur fyrir Fífuhvamsveg. Framkvæmdir hófust í september 2015, verklok voru áætluð 1. október 2016 en seinkaði af ýmsum ástæðum. Á vegkaflanum voru gerð þrenn gatnamót og tvenn undirgöng. Einnig var sett upp veglýsing, stígar gerðir, land

mótað, hljóðvarmir settar upp og annað sem nauðsynlegt er til að ljúka verkinu.

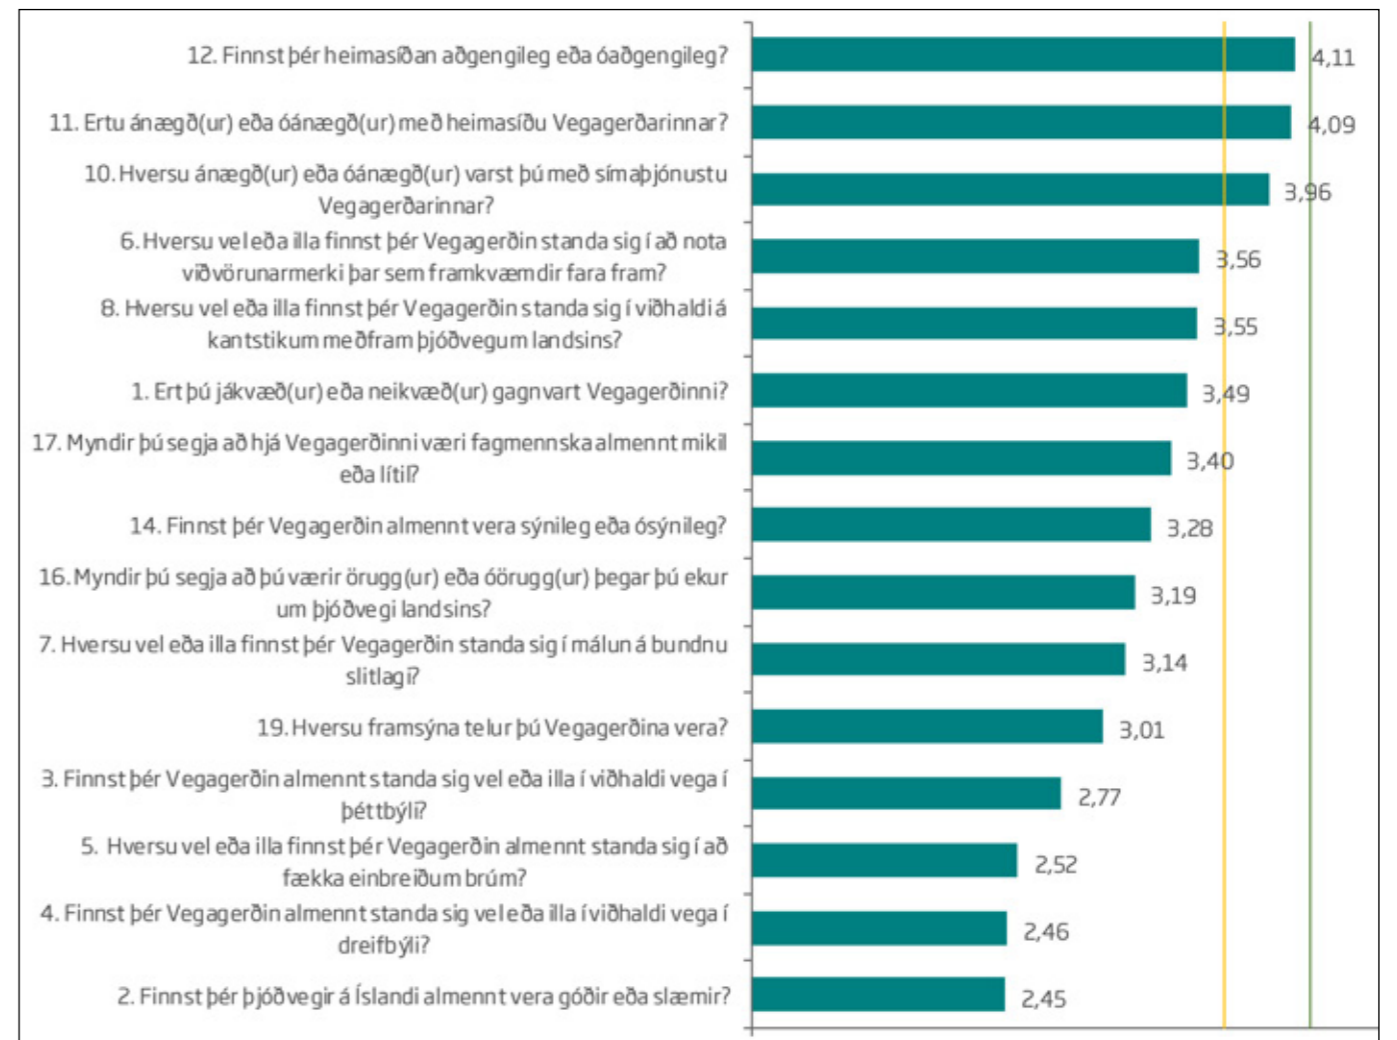
Helstu niðurstöður könnunarinnar á fimm stiga kvarða sýna hvar eru sóknarfæri hjá Vegagerðinni til að bæta úmynd sína hjá almenningi.

Hægra megin við **græna lóðlínu**: Styrkleikabil (4,20-5,00).  
Milli **gulu** og **grænu lóðlínu**: Tækifæri til nokkurra úrbóta (3,70-4,19).  
Vinstra megin við **gula lóðlínu**: Tækifæri til mikilla úrbóta (1,00-3,69).

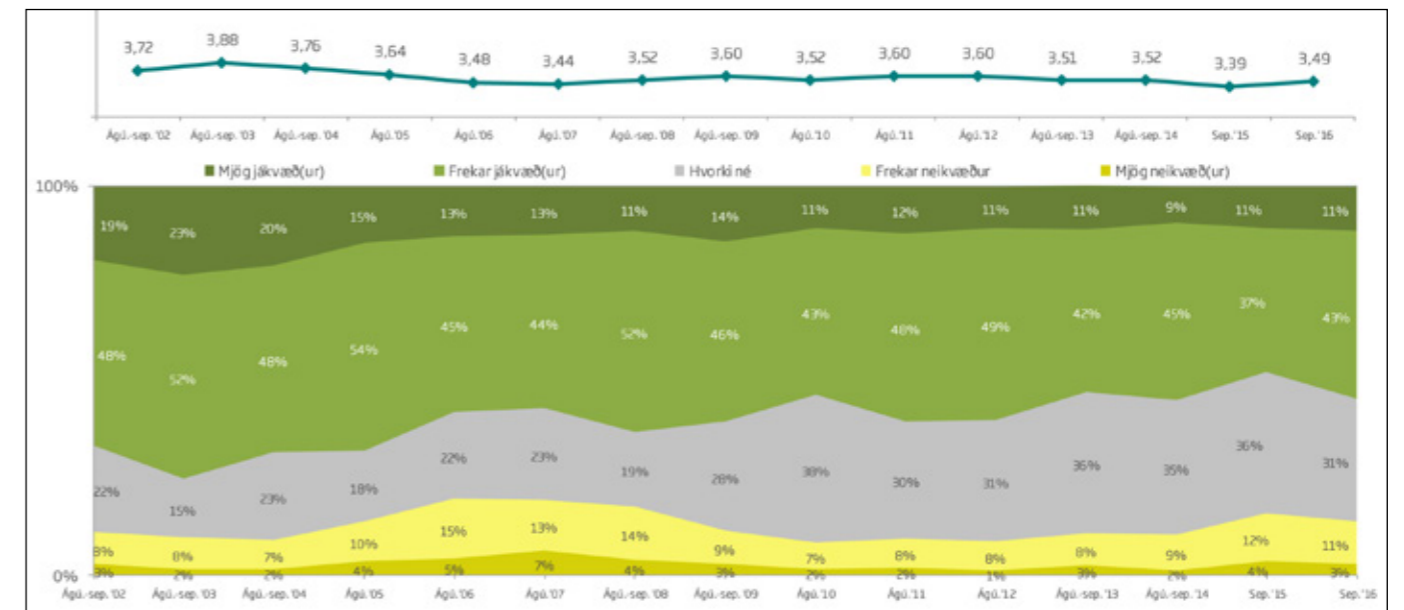
Spurningin „Ertu jákvæður eða neikvæður gagnvart Vegagerðinni?“ Þróun svara frá árinu 2002.

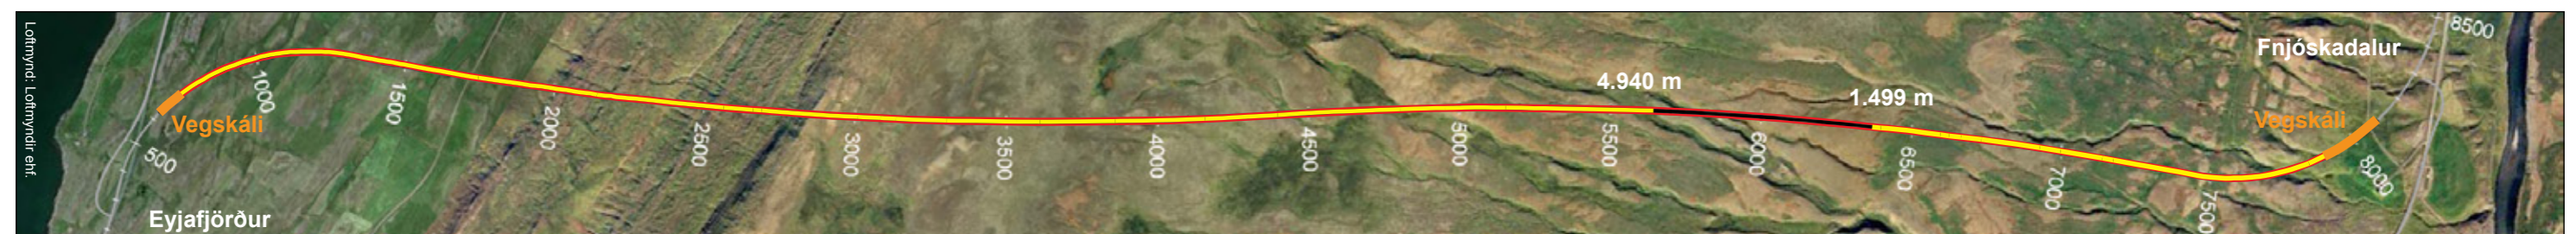
Vaðlaheiðargöng, staða framkvæmda 14. nóvember 2016. Búið er að sprengja samtals 6.439 m sem er 89,4% af heildarlengd.

Heildarlengd ganga í bergi 7.206 m, vegskálar ekki meðtaldir. Sjá: [www.vadlaheidi.is](http://www.vadlaheidi.is)

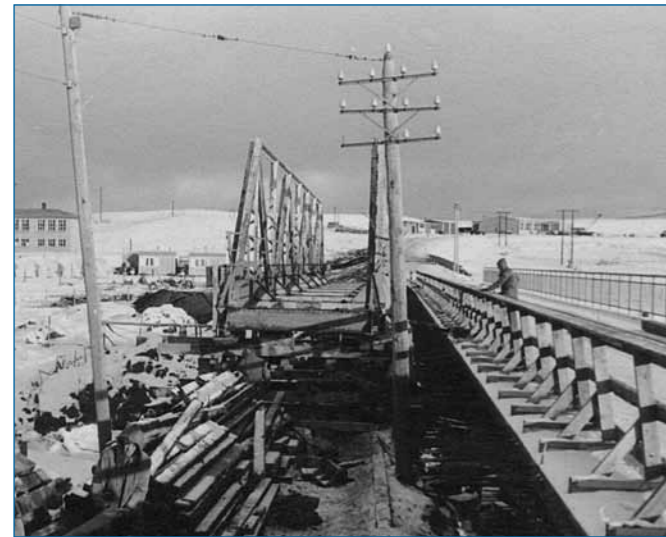
Bygging Blöndubrúar 1962. Fyrir í brúarstæðinu var gömlu stálgrindarbrú. Því var hægri akrein nýju brúarinnar byggð fyrst. Síðan var umferð hleypt á þann brúarhluta en gamla brúin fjarlægð (og flutt á Svartá). Að því loknu var vinstri akrein nýju brúarinnar byggð.

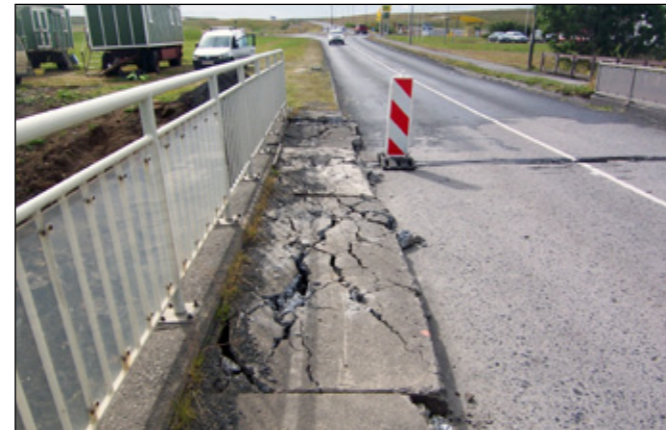
Ástand Blöndubrúar áður en viðgerðarvinna hófst.

Nú í haust hefur brúavinnuflokkur Vegagerðarinnar frá Hvammstanga unnið að viðgerð á brúnni yfir Blöndu þar sem Hringvegurinn (1) liggur um Blönduós. Brúin var byggð 1962 og 1963, sú fyrsta hér á landi sem var gerð úr eftirspenntri steinsteypu. Heildarbreidd brúar er 9,63 m. Akbrautin var mjókkuð nokkuð árið 1991 þegar gangbraut með handriði var sett á vinstra kant, á leið norður (undan straumi). Líklega var hugmyndin að minnka umferðarhraða í gegnum þéttbýlið. Nú hins vegar þykir akbrautin full mjó fyrir stærstu bíla til að mætast á og því var ráðist í talsverðar endurbætur um leið og slitgólfið var endurnýjað, gera nýja brík hægra megin (á móti straumi), með vegriði í samræmi við kröfur í dag, og mynda þakhallu á akbraut en yfirborðið var áður nánast með engum hliðarhalli. Eftir framkvæmdina verður „slettuvarin“ gangbraut á vinstri kanti eins og áður en upphækkuð ræma á hægri kanti hefur verið fjarlægð.

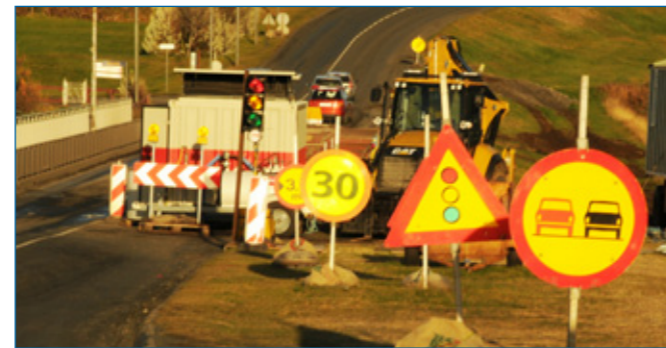
Ljósastýring umferðar á meðan aðeins er opin ein akrein á Blöndubrú.

Vinna þurfti verkið á einni akrein í einu með umferð á hinni akreininni. Sett voru upp umferðarljós til að stjórna umferð um eina akrein á meðan verkið stendur yfir.

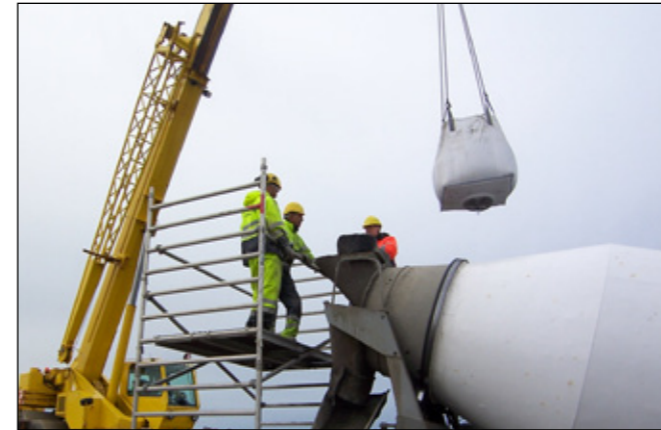
Steypa blönduð í steypubíl á staðnum.

Reynt er að vanda steypublönduna sérstaklega með réttu magni og kornakúrfu steinefna, sements, stál- og plastrefja, mismunandi íblöndunarefna og vatns. Engin steypustöð er á Blönduósi en sú næsta er á Sauðárkróki. Það þótti því tilvalið að prófa að blanda steypuna beint í steypubíl á staðnum, svokölluð truckasteypa. Það er hluti tilraunaverkefnis til að skoða hvort mögulegt sé að framleiða hágæða steypu með þeirri aðferð þegar langt er til steypustöðva sem eru þannig búnar að þær geti annast það. Tilraunin gekk m.a. út á að skoða hvernig mætti standa að blönduninni, þannig að hraðinn væri nægur m.t.t. niðurlagnarinnar. Tveir steypubílar voru notaðir í verkið.

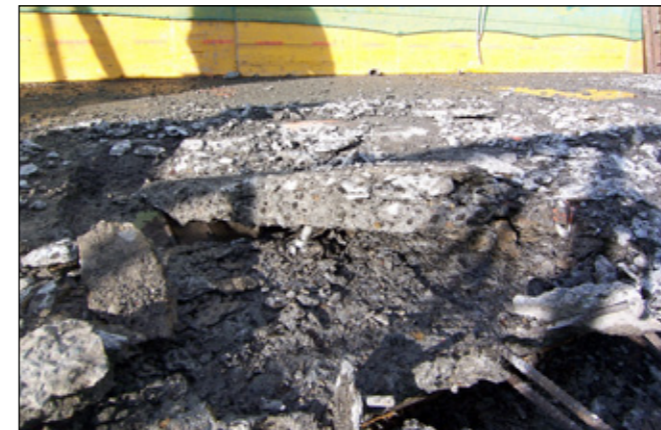
Steypuskemmdir yst í hægri akrein.

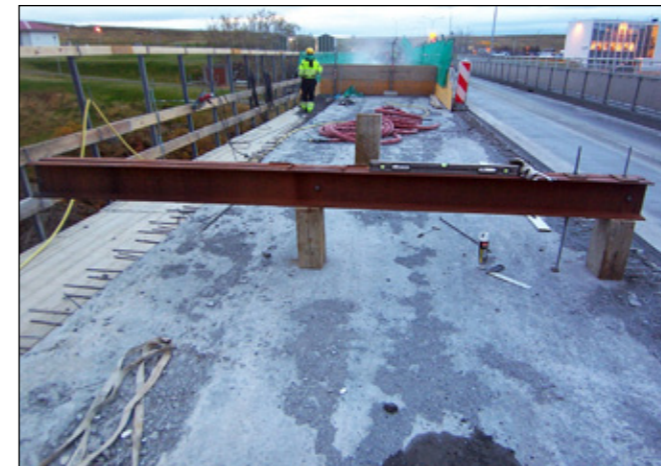
Stálbitar til að halda uppi undirlætti. Innri endi er festur niður með tveimur teinum sem eru línðir niður í brúargólfið.

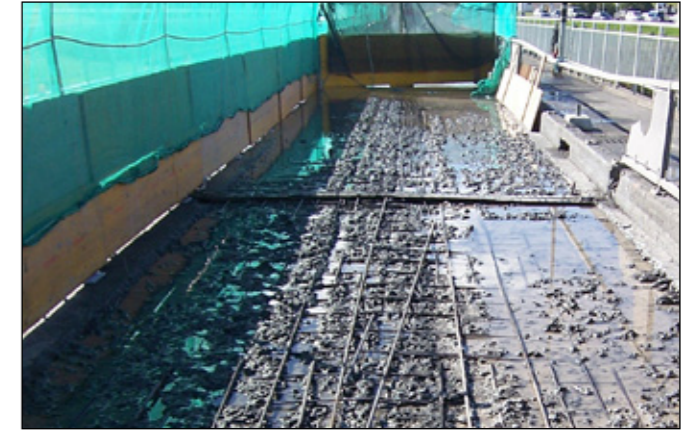
Vinstri akrein eftir vatnsbrot.

Á Blöndu var efsta lag gömlu steypunnar í brúardekkinu brotið með vatnsþrýstingi og átti meðalþykkt að vera 40 mm. Raunin varð sú að talsvert þykkara lag var fjarlægt að stórum hluta, sérstaklega yst á hægri akrein en þar komu í ljós talsverðar steypuskemmdir sem náðu jafnvel í gegnum brúargólfið. Viðgerðirnar urðu því mun umfangsmeiri og þurfti að setja upp röð stálbita yfir brúargólfinu til að halda uppi undirlætti fyrir þessar viðgerðir. Að öðrum kosti hefði þurft að slá upp verkpöllum undir brúna sem hefði verið mun meira verk og dýrara. ■

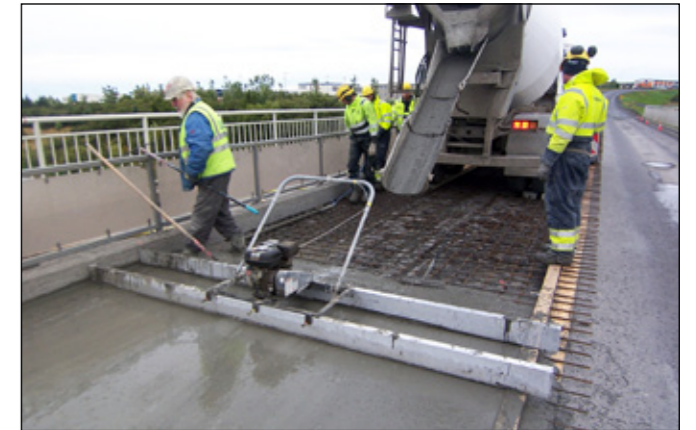
Steypa lögð út á vinstri akrein. Sjá má nýja járnabindingu.

Þessi steypa er hálsjálftúleggjandi, hana þarf ekki að titra til að hún leggist rétt. Hún er án loftblendis og frostþolin vegna lágs vatns/sements hlutfalls (< 0,3). Steypa er talin bindast mjög vel við undirlag. Endurbætur á Borgarfjarðarbrú sem

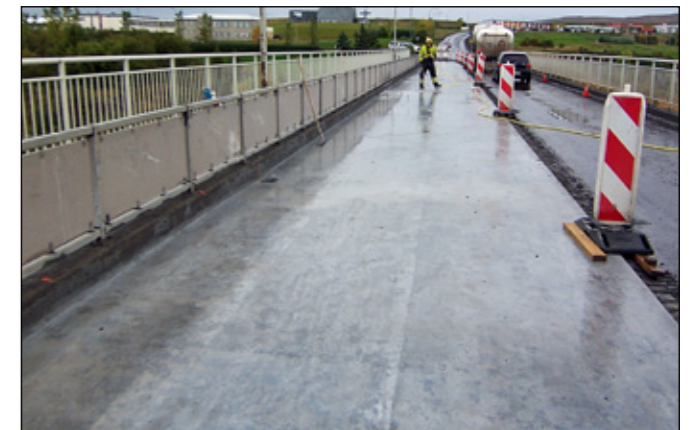
Yfirborð nýju steypunnar er mjög slétt.

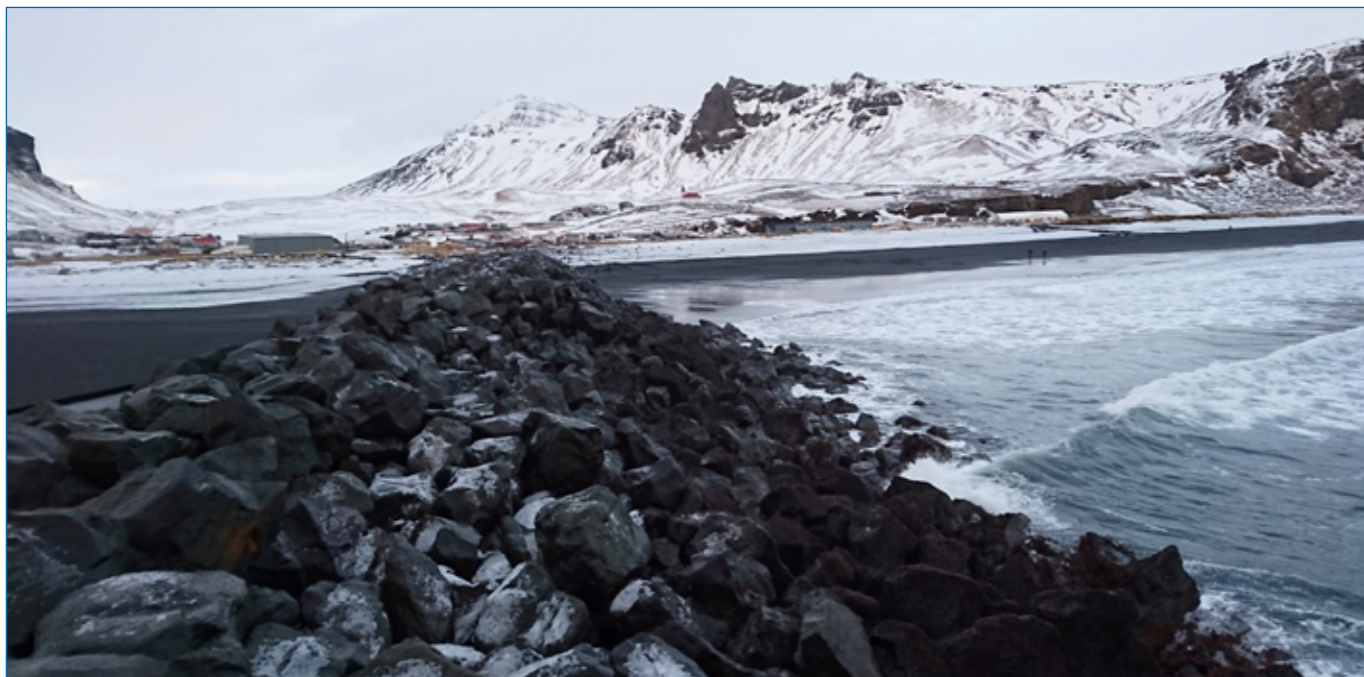
Vík í Mýrdal, sandfangari sem var byggður 2011, sjá niðurstöðu útbóðs hér á síðunni.

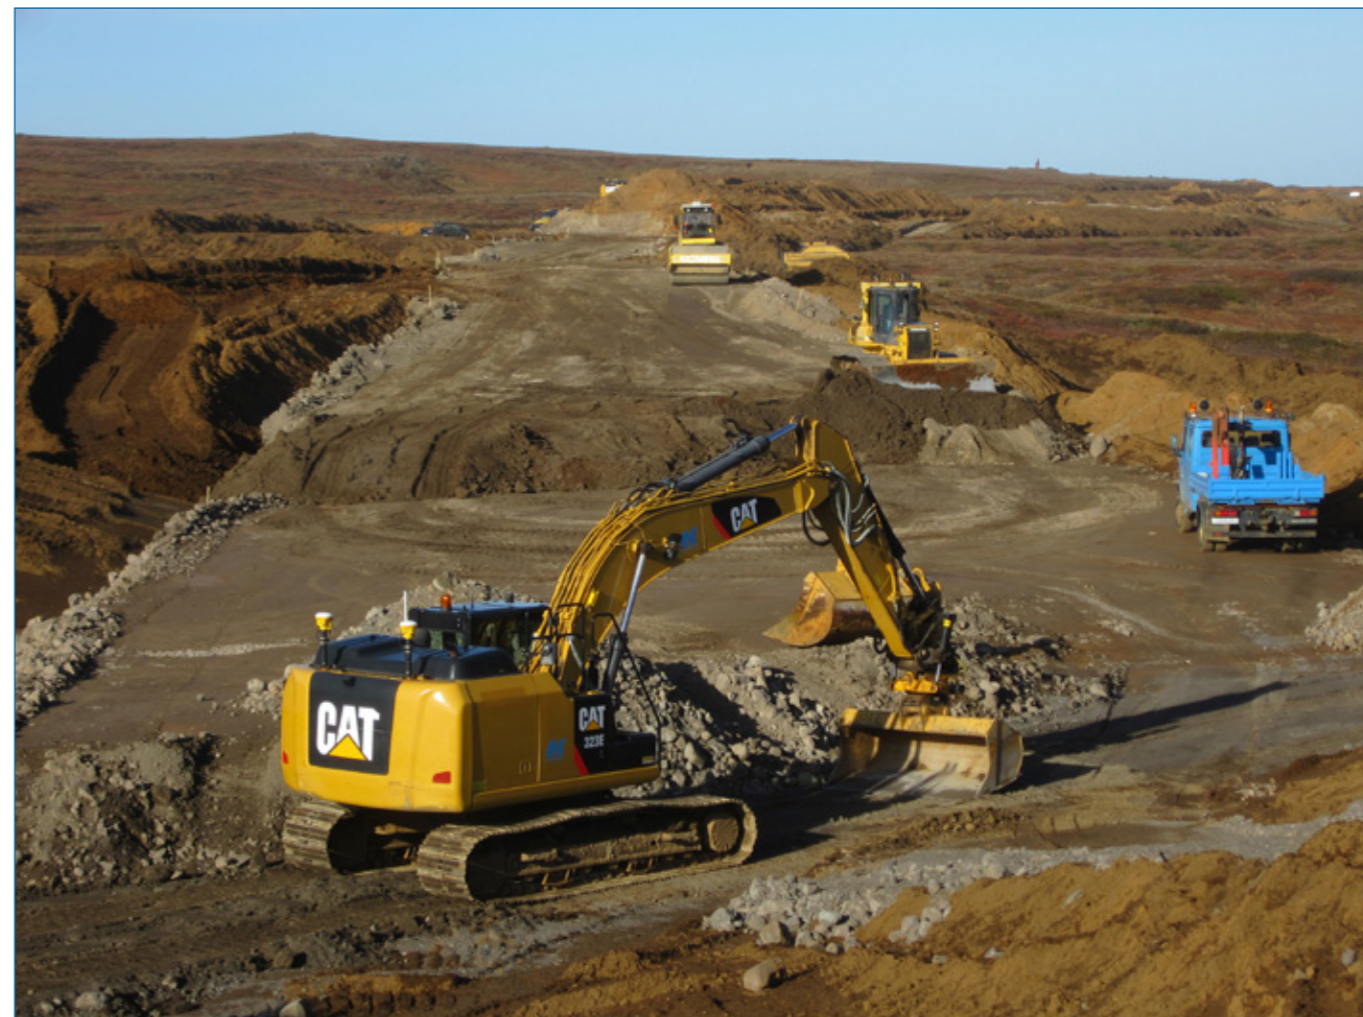
Framkvæmdir við Dettifossvog 3. október 2016.

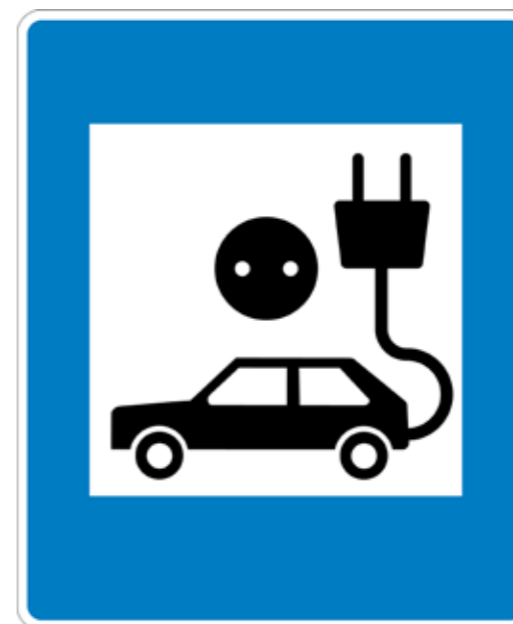
E03.16 Hleðsla fyrir rafbíla

Merki þetta vísar á stað þar sem hægt er að komast í rafmagn til að hlaða rafbíla.

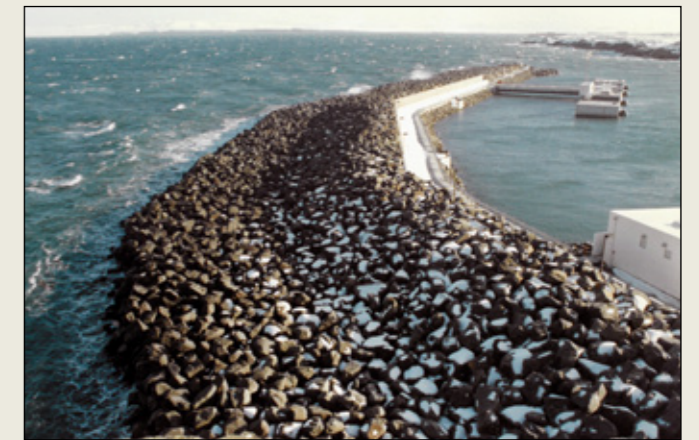
Figure 1.2. Berm breakwater of Helgusvík, Iceland. Designed in 1983 by Baird & Associates and constructed in 1986-1988 by Icelandic contractors.

structed in Canada: Codroy in Newfoundland and North Bay in Ontario. The Helgusvík breakwater in Iceland had also been designed by Baird & Associates, but was constructed a little later. Figure 1.2 shows the Helgusvík breakwater more than twenty years after construction. Although the intention was to have a reshaping berm breakwater, the berm has hardly been reshaped during this period as quite some safety was used in the detailed design, mainly through the establishment of design wave height.

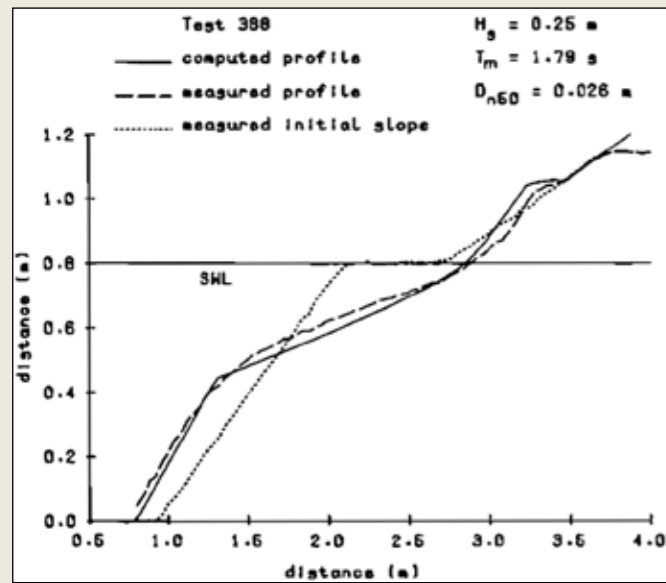
Figure 1.3. Berm-type profile in research on dynamic stability of [Van der Meer, 1988-a]. Test 388, including calculated profile by Breakwat;  $H_s/\Delta D_{n50} = 5.9$ .

A week after the conference in Houston, Baird and Van der Meer met each other in Ottawa, discussing the berm breakwater concept and dynamic stability with profile formation. It led to restructuring of Van der Meer's research on rock slopes and gravel beaches, including some tests with berm profiles (Figure 1.3).

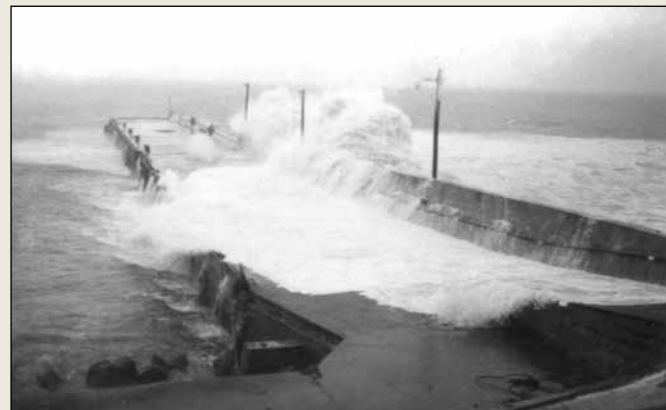
Figure 1.4. Overtopping during a storm at the pier of Hofsós before construction of the berm breakwater.

In 1983, two berm breakwater projects were initiated — a new breakwater at Bakkafjörður (see Section 9.5.2) and an overtopping protection of an existing pier at Hofsós. The existing pier at Hofsós showed too large and frequent overtopping (see Figure 1.4).

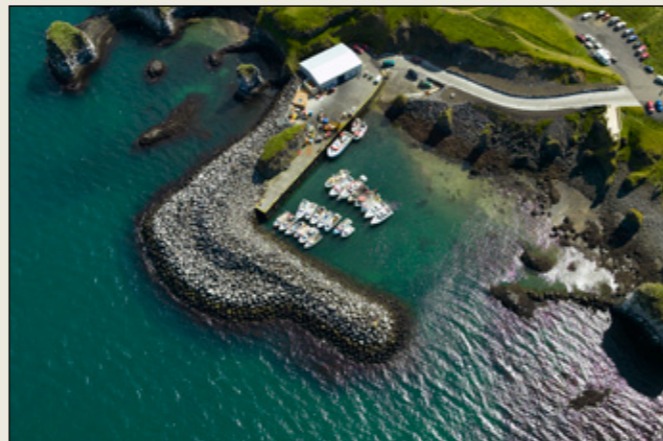
Figure 1.7. The berm breakwater at Arnarstapi, Iceland, sheltering a small fishing harbour. Photo Mats Wibe Lund.

The year after, in 1984, three more projects were initiated. At Arnarstapi an extension of an existing breakwater protecting a small fishing harbour was constructed. The berm structure at Arnarstapi was constructed from 1984-1985 and was rebuilt and extended by 45 m of conventional rubble mound in 2002 (see Figure 1.7). Another new berm breakwater was constructed at Nordurfjörður (see Figure 1.8). With a stability number of  $H_s/\Delta D_{n50} = 2.4$  on the trunk of the berm at Nordurfjörður, the berm has fully reshaped, while on the roundhead the berm holds its shape due to larger armourstone.

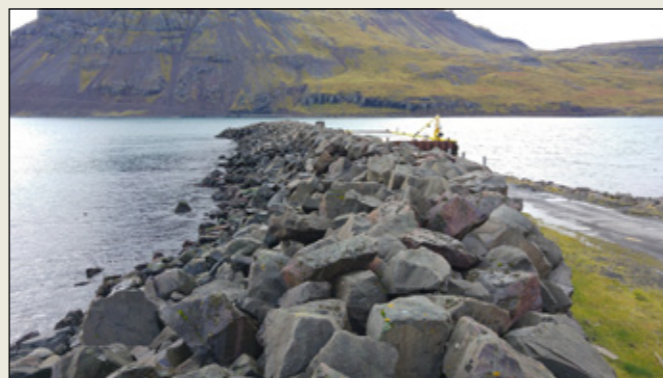
Figure 1.8. The berm breakwater at Nordurfjörður, Iceland, 30 years after construction (1984-1985). Photo R. Kamska.

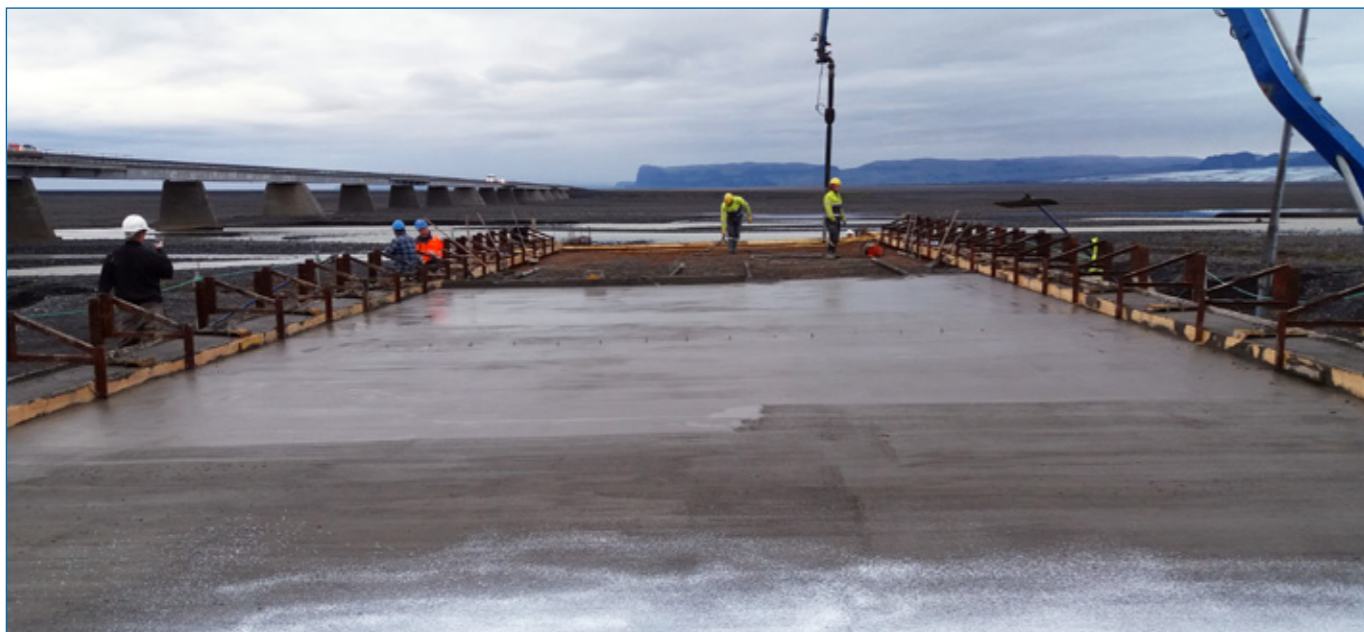
Steypuvinna við Morsá 16. október. Skeiðarárbrú sést til vinstri og Lómagnúpur er í baksýn.

Útlögn var skipt í tvo áfanga og notaður seinkari til að koma í veg fyrir steypuskil. Í fyrri áfanga voru ca. 44 m af yfirbyggingu steypdir, eða um 364 m<sup>3</sup> og restin 24 m eftir hvíld hjá starfsmönnum. Fyrsti steypubíll var kominn á verkstað ca. kl. 8:00 á laugardagsmorgni og síðasti um kl. 22:00 um kvöldið. Þá var tekið hlé í útlögn í ca. 11 klst. Hafist handa aftur kl. 8:00 á sunnudegi og síðasti bíll kom kl. 18:00.

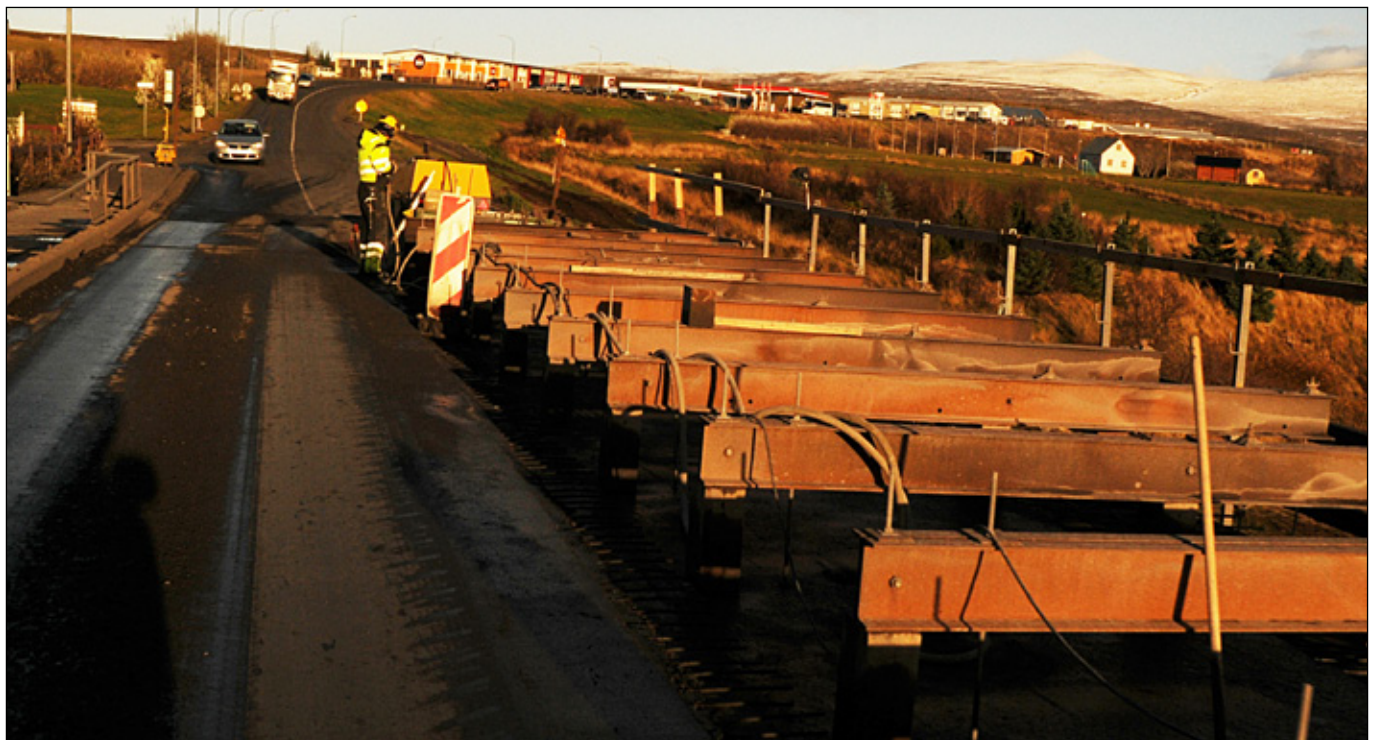
Viðgerð á Blöndubrú, sjá bls. 4-5.

Steypa sem er notuð í brúargólfi er slitsterk, veðrunarþolin og rýrnunarlítill hástyrkleikasteypa. Hún hefur verið í þróun hjá Nýsköpunarmiðstöð Íslands í samvinnu við Vegagerðina.
