Annele Matintupa, Seppo Tuisku

SUMMARY OF DRAINAGE ANALYSIS IN ICELAND

Demonstration Project Report

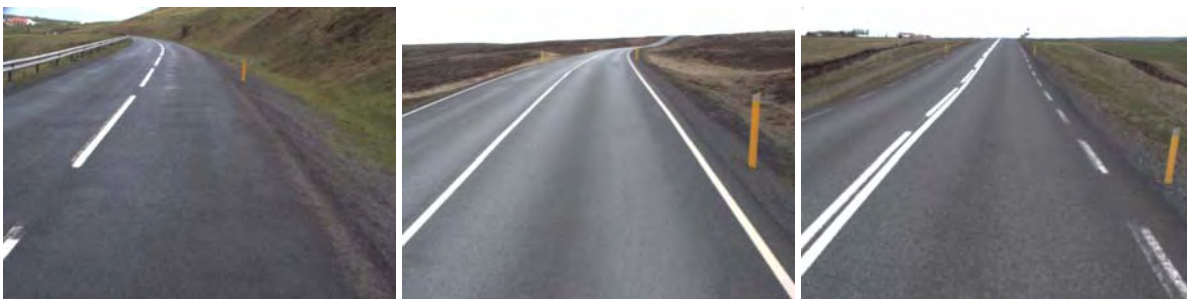
Drainage Class 1 means that the drainage condition is faultless. The cross-section of the road has preserved its form well and water flows unrestricted from the pavement to the ditch. Water has also a clear passage in the ditches. Examples of drainage Class 1 are presented in Figure 6.

Figure 6: Examples of road sections with drainage Class 1 in Icelandic road network.

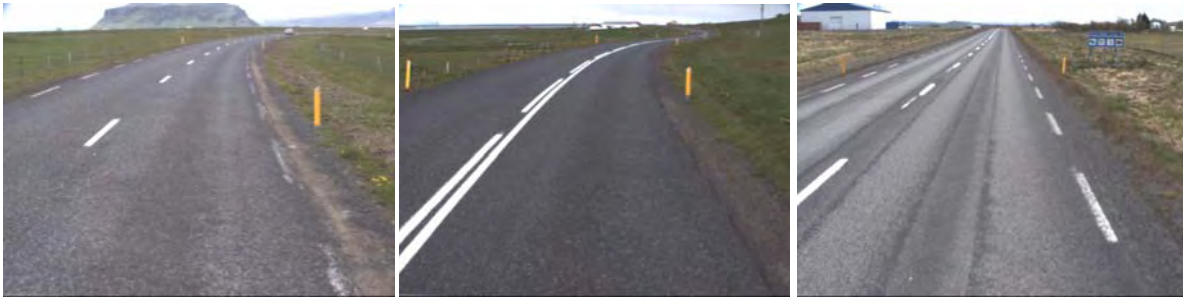
In drainage Class 2 there can be some visible changes to the road cross-section. The road shoulder has narrow verges or vegetation growth that is preventing the free flow of surface water from the road surface into the ditch. There is some vegetation in the ditch that restricts water flow and creates damages. Some soil is sliding from the road side slope into the ditches and raising the bottom of the ditch. This hinders water flow and raises the ground water level. Examples of drainage Class 2 are presented in Figure 7.

Figure 7: Examples of road sections with drainage Class 2 in Icelandic road network.

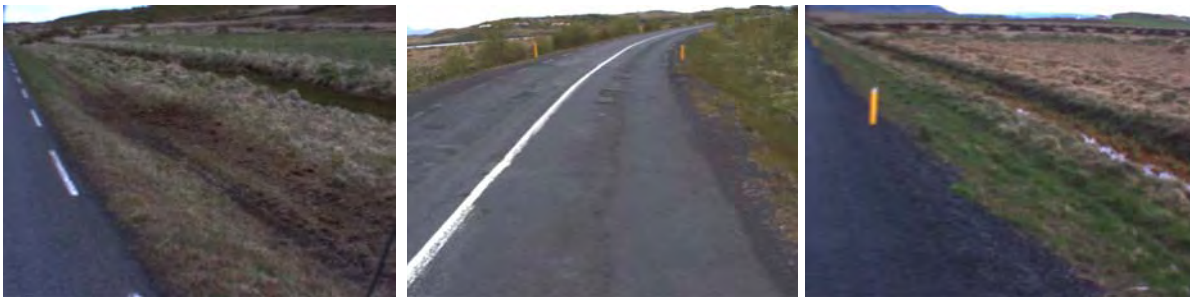
Drainage Class 3 covers those road sections with severe drainage problems. The road shoulder has a high verge and/or dense vegetation that are causing ponding on the traffic lane or on the shoulder. Vegetation is growing in the ditches and restraining the flow of water creating dams in the ditches. Unstable soil is flowing from ditch slopes into the bottoms of ditches and blocking the flow of water. Clogged culverts or outlet ditches is preventing the flow of water in the ditch. All of these situations lead to the development of deformation and damage in the road cross-section. Examples of drainage Class 3 are presented in Figure 8.

Figure 8: Examples of road sections with drainage Class 3 in Icelandic road network.

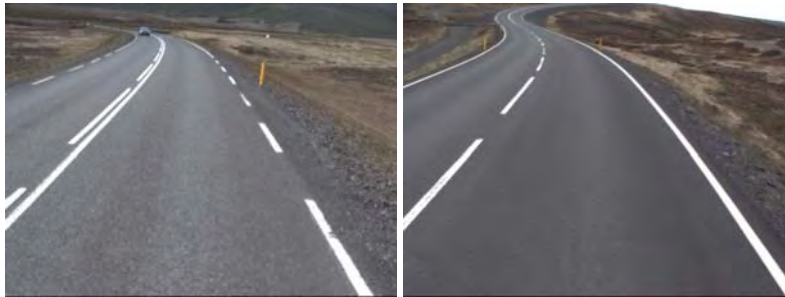
Figure 9: Two examples of verge Class 1, i.e. road sections without verges.

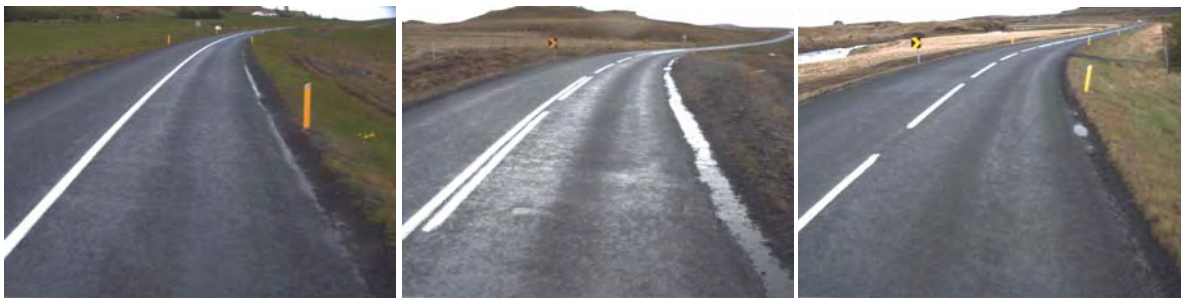
Class 2 (verges exist) cover all road sections with verges. The height of verges can vary from low verges, which only have a minor effect to drainage, to high ones which clearly prevent surface water flowing away from road surface. In Iceland the existing verges for the most part were low. Examples of verge Class 2 are shown in Figure 10.

Figure 10: Examples of verge Class 2, roads with a verge. The effect of verges on the workings of the road drainage system varies greatly in different circumstances.

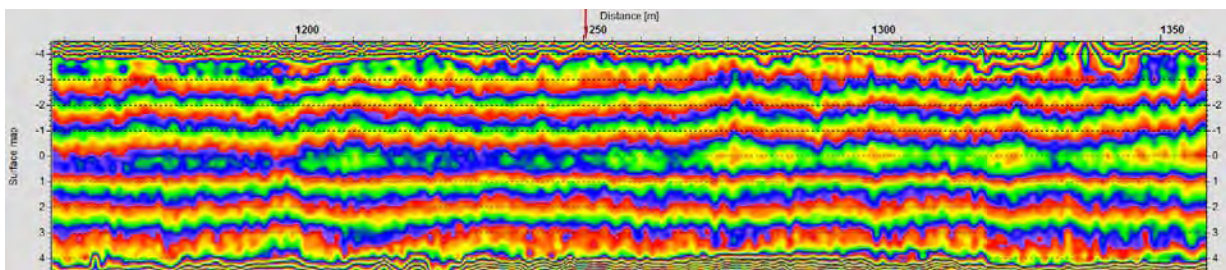
Figure 12: A rainbow map of a road section, which has a good crown section. Each complete colour palette represents 40mm change in surface level relative to the centreline.

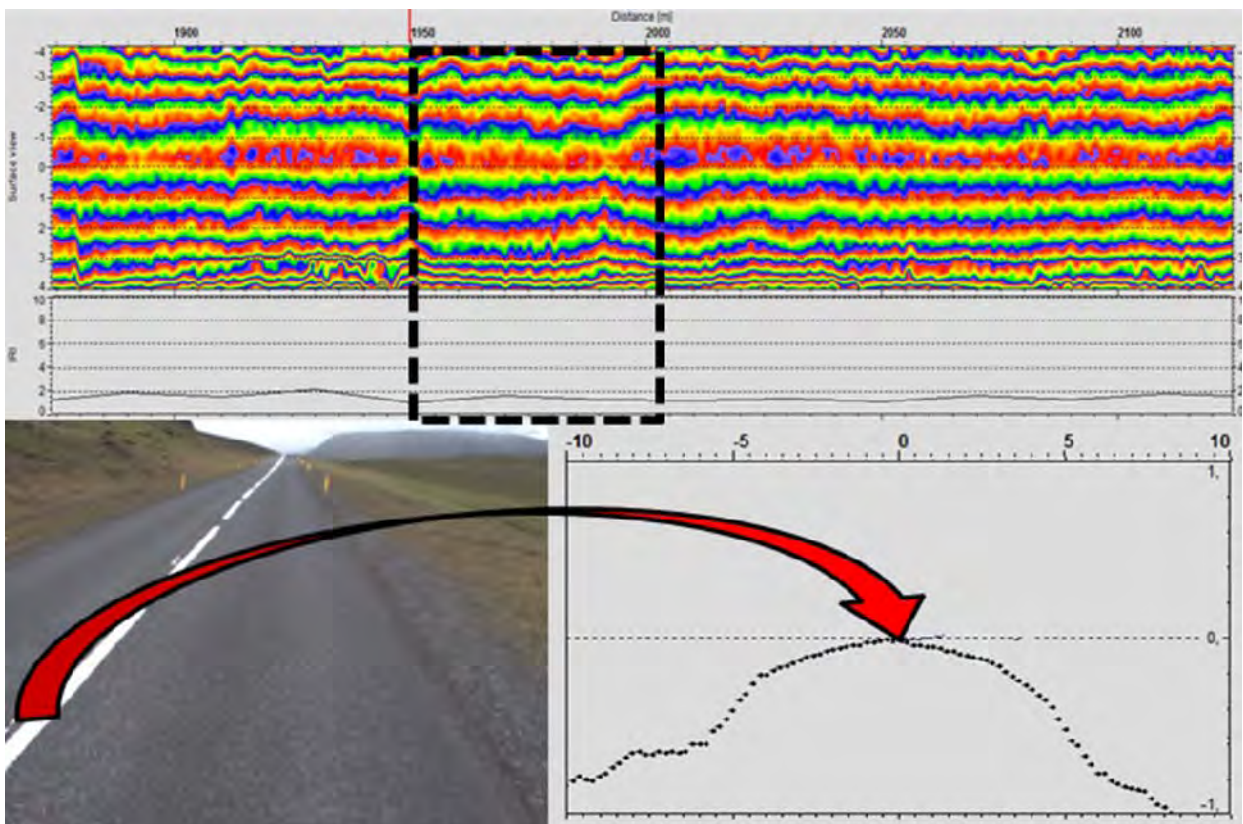
Figure 16 shows an example rainbow map of a section of road B4 which has generally a well shaped crown section.

Figure 16: Road section with low IRI (2mm) values and a good crown section as seen from the rainbow map (black dotted line) and from the cross section picture (Chainage 1950m).

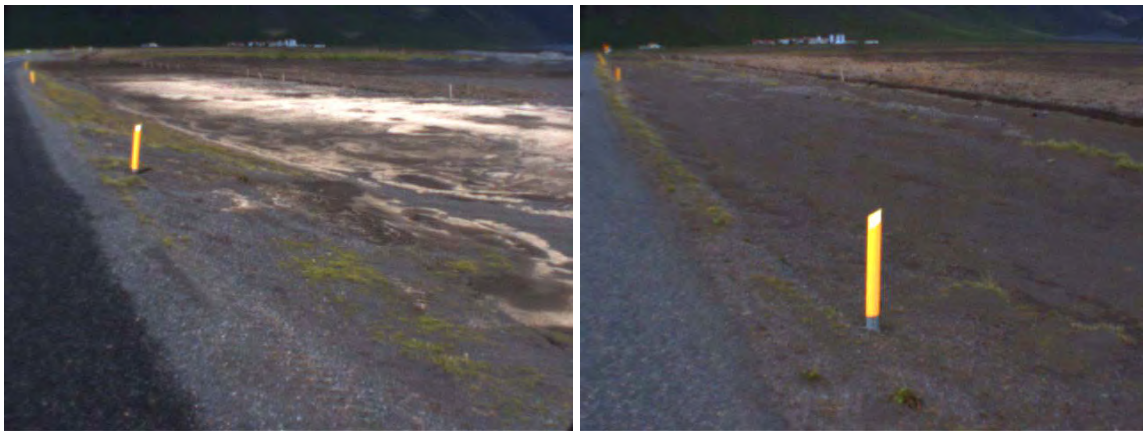
Section B7 of road 1 was measured from the junction of road 242 to the junction of road 247, a section length of 13100m. Ash remains from the 2010 eruption were visible at the beginning of the section but mostly the ditches were clean and the drainage was working efficiently (Figures 18).

Figures 18: Volcanic ash from the eruption was still visible in the ditches (at chainages 130m and 480m)

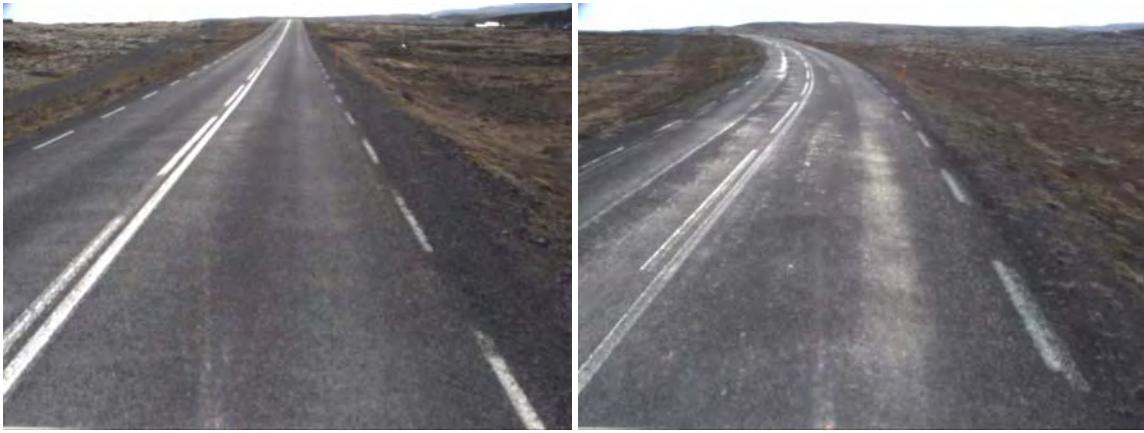
Road 38 survey started from the roundabout where the road 38 begins. The length of the section was 11600m and the section ended at its junction with road 39. Statistically the drainage was in excellent condition, more than 93% of the road was in drainage Class 1. The terrain was extremely dry, especially in the end part of the section (Figure 44).

Figure 44: Dry terrain in the end part of the section (chainage 9900m (left), 11000m (right)).

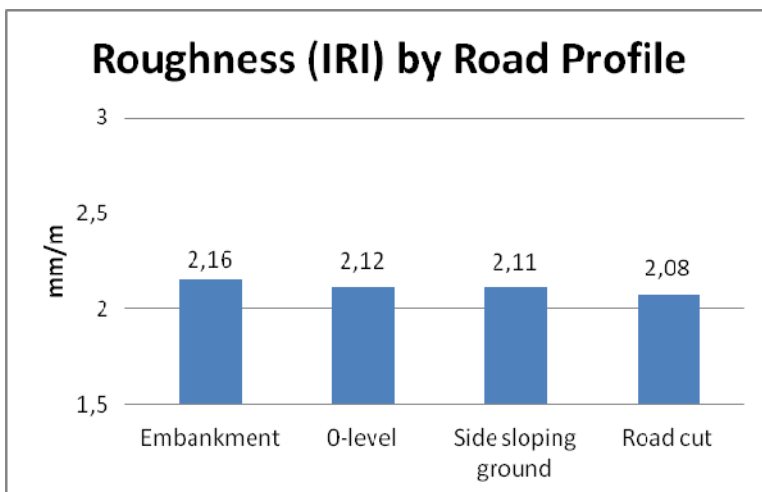
Figure 60: IRI values by road profiles in Iceland. IRI values are 20m averages.

In general, road profilometer data in the other demonstration projects correlated well with the drainage deficiencies identified. However in the surveyed Icelandic roads the analysis showed that IRI data did not correlate with drainage conditions, and actually IRI values were lower in drainage Class 3 than in Class 1 (Figures 59-60).

The most likely reasons for this evenness in the roughness data were the amount of dry terrain, and the exceptional road profile distribution. The dry terrain also helped with the average drainage condition which was at a very good level. As already mentioned, the prevailing road profile in the surveyed road sections was embankment, approximately 57%. On embankments drainage deficiencies usually have less impact on road condition.

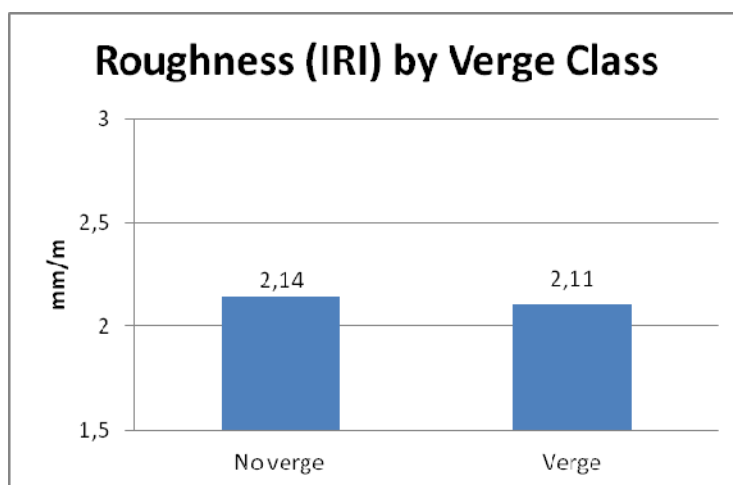
Figure 61: IRI values by verge class in Iceland. IRI values are 20m averages.

In the roads surveyed in Iceland there was not a discernible change in IRI values between sections with or without verges (Figure 61). Part of the explanation could be the data itself which was, as already mentioned, relatively old.

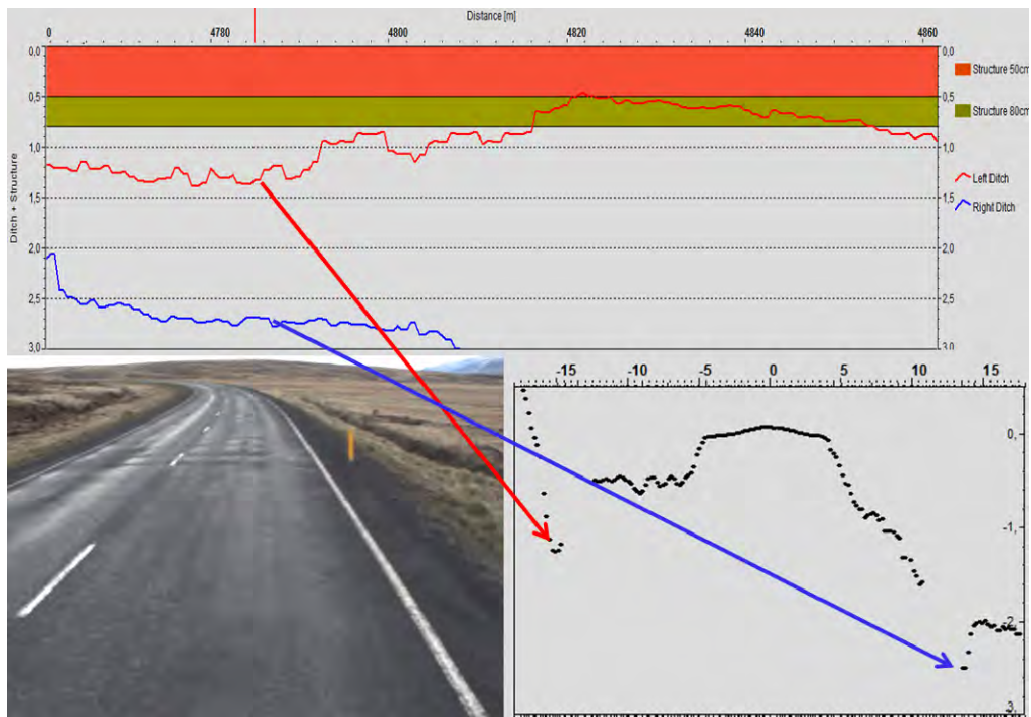
Two example sections from section 11 on road 36 are shown in Figures 62 and 63. A GPR survey was not carried out as part of the Icelandic demonstration project so the bottom of the road structure could not be determined. The coloured bars on top of the figures represent the assumed bottom of the structure which is divided into two layers. The uppermost red bar in both figures represents a 50cm thick road structure and the green bar represents an 80cm thick structure. The red line represents the bottom of the left ditch calculated from the road centreline elevation and the blue line represents the bottom of the right ditch. On Figure 62 the left (red) ditch is shallow from 4820m to 4850, and the right (blue) ditch is deeper than the scale (3.0m) from 4810m onwards.

Figure 62: Ditch depth shown as a continuous ditch depth field and as a cross section view at chainage 4785m. The red arrow indicates the left ditch and the blue arrow indicates the right ditch. On the left from 4820m to 4850m there was a short section where the ditch was shallow.

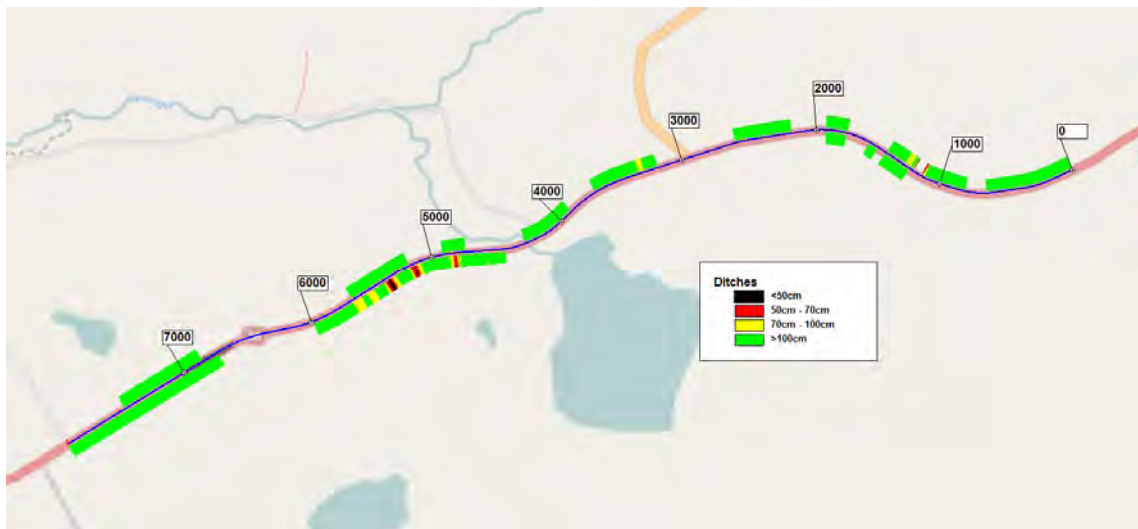
The roadside ditch on the left was shallow for a few short sections from 4700m to 5600m. Where the ditch depth is not shown on the map it was either too far from the road or there was not a need for a ditch at all.

Figure 64: Ditch depth map of section 11 on road 36.

The drainage analysis of the surveyed road sections in Iceland identified those sections that had drainage deficiencies even though they had minor effects on the adjacent road condition. It is recommended that those sections, and the poor outlet ditches identified, should be improved. In this way, possible problems in the future can be avoided.
